REPORT

Fire analysis of the events at Waco, Texas, 19 April 1993

The Office of Special Counsel

Ulf Wickström
SP, Swedish National Testing and Research Institute
Borås, Sweden
September 2000

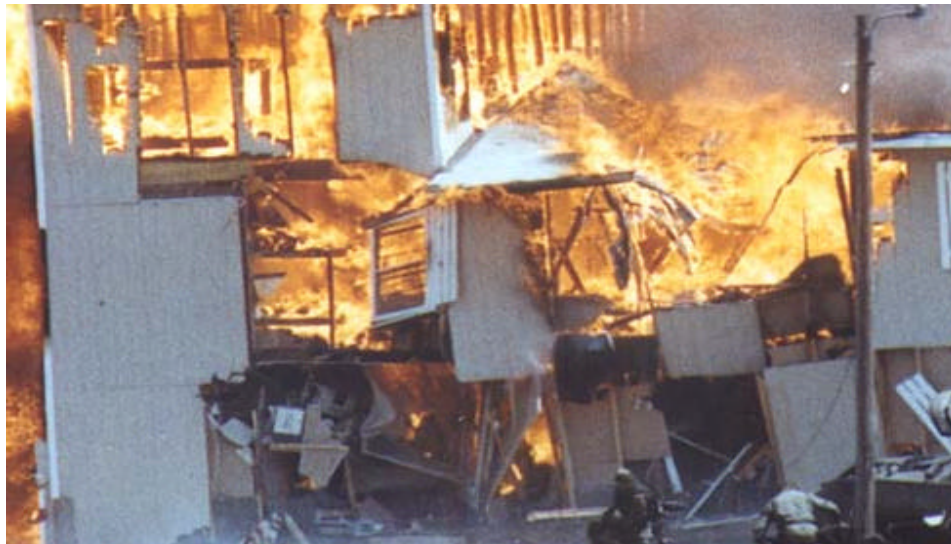
Figure 2.1 FBI ground photo of Green/White tower. The front wall was covered on the external side with wood panels and on the inside of first two floors with drywall (gypsum boards). The tower second and third floor walls had no internal claddings.

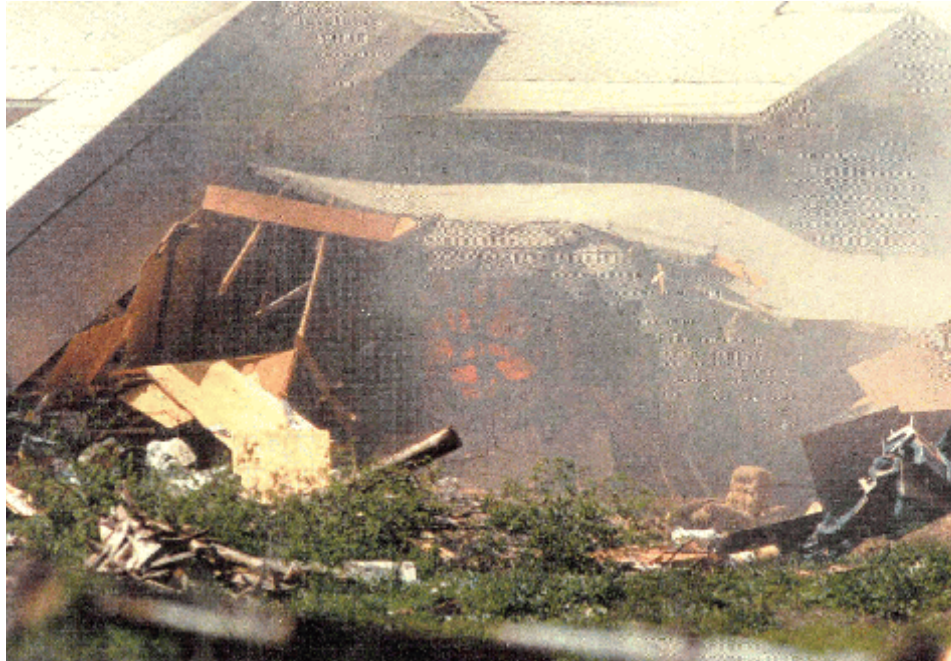
E-12

An FBI agent took a ground photo from the Black Side, Figure 2.6 between 12:09:10 and 12:10:21 showing the fire developing in the damaged building under the collapsed catwalk roof. The time range was determined by comparisons with FLIR recordings. A CEV, which left the gym area at about 12:09:10, cannot be detected on the photo and a heated plume emerging outside the gym occurs on the FLIR at 12:10:21. The fire

started further into the building, in the stage area, and was driven by the wind towards the Black Side.

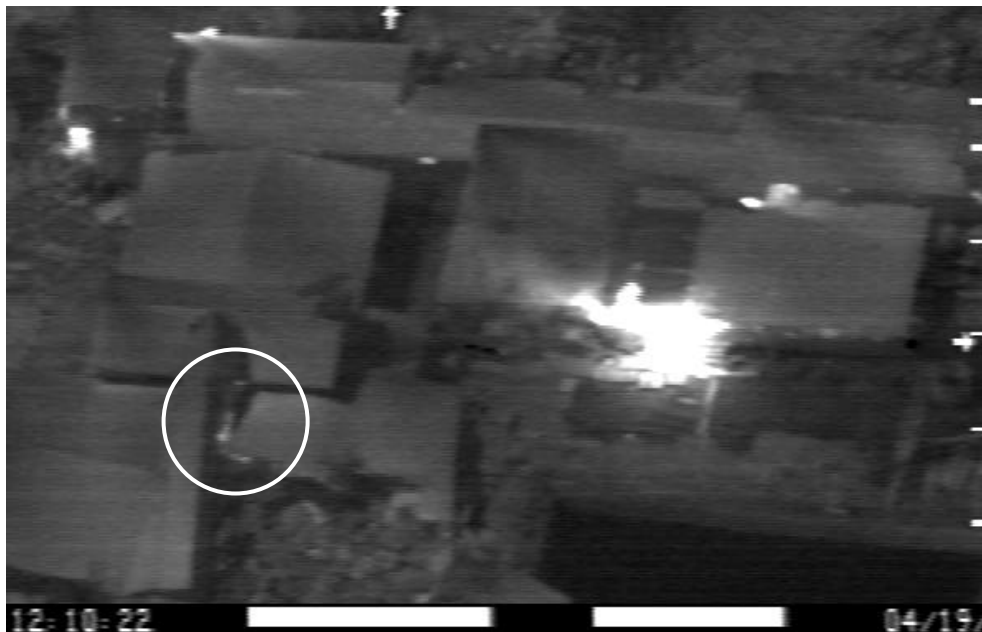
Heat images in the area of the fallen catwalk quickly develop into intense flaming and were also detected on the FLIR imagery at 12:10:21, see Figure 2.7.

Figure 2.7 FLIR image from 12:10:22. A strong heat image started to appear at the eaves of the collapsed catwalk at 12:10:21. It developed quickly into intense flaming.

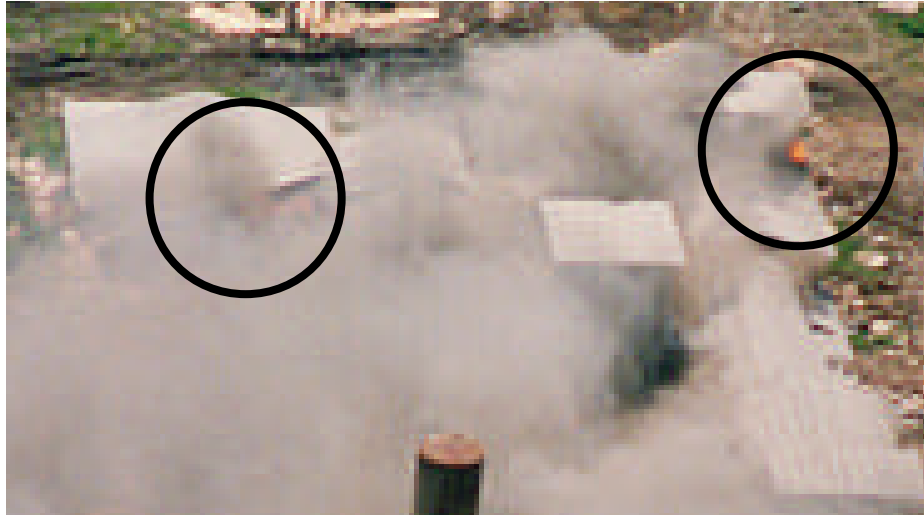
Photo 7-6

The aerial photo where flames are seen was taken about 12:11 p.m., see Figure 2.8.

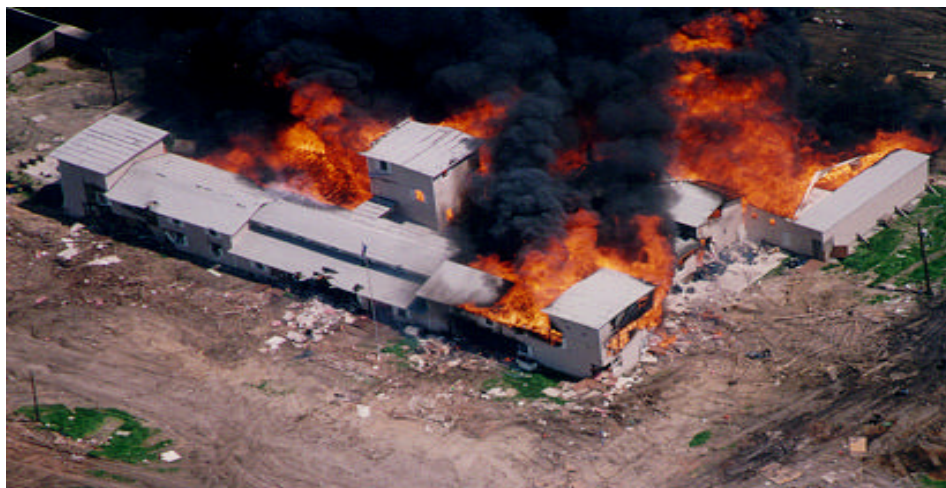
Photo 7-36

Fire A then burnt intensively and generated large amounts of black smoke when the asphalt of the roof covering got involved. The wind, however, hampered the fire from spreading to the rest of the complex, and not until a rather later stage did it merge with fire C, which started in the Red/White tower, see Figure 2.9.

At about 12:16 p.m. the Red/White tower walls start to burn through, see Figure 2.9.

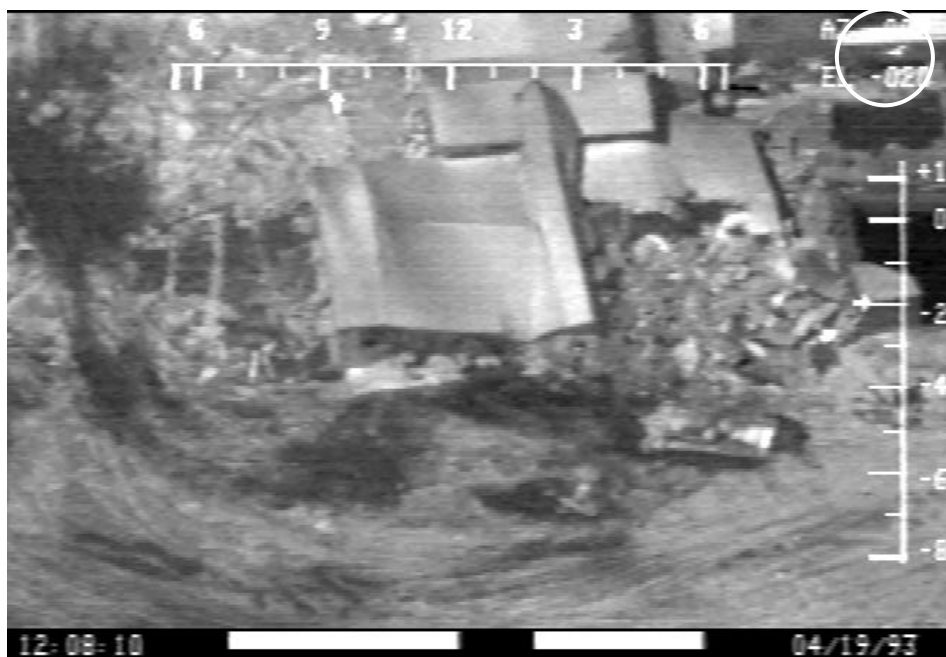
Fire B started in the cafeteria/kitchen. It was first detected by the FLIR at 12:08:10, see Figure 2.10.

Figure 2.10 FLIR at 12:08:10. The first sighting of fire on the cafeteria wall.

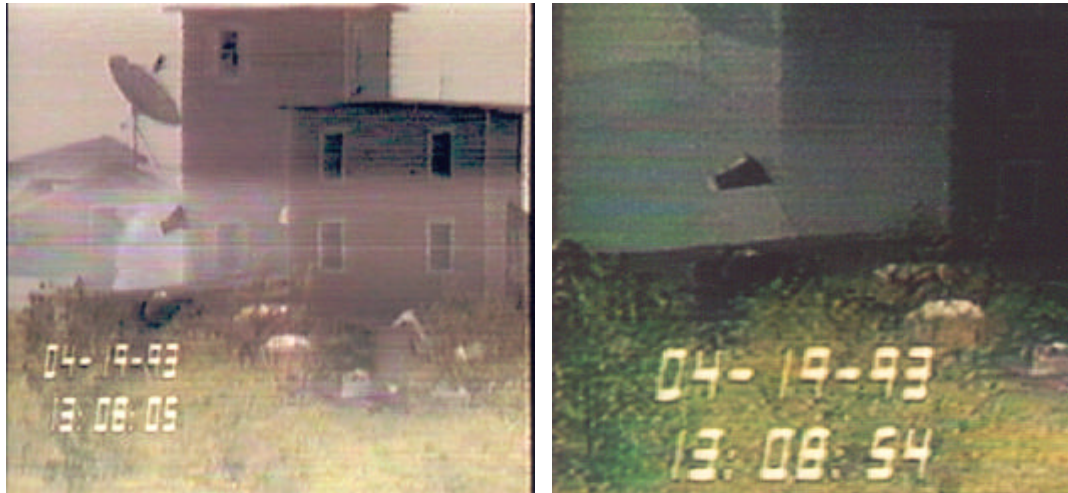
Shortly afterwards at 12:08:11 white smoke over the cafeteria roof came in sight in the CBC TV sequence. The smoke peaked after about a minute and then the intensity seems to go down, see Figure 2.11.

Figure 2.11 CBC at 12:08:24 and at 12:09:13. White smoke coming out from the rear of cafeteria. (For correction of time, see Section 2.3.)

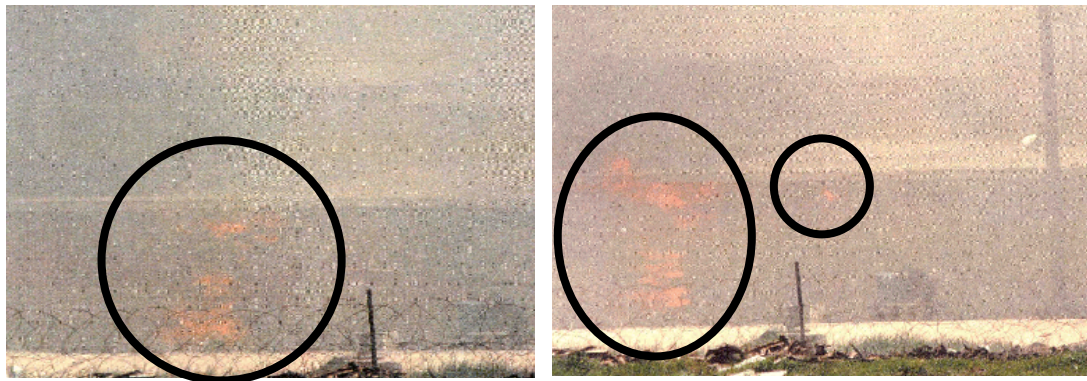
A series of ground photos were taken by the FBI some time between 12:08:10 and 12:08:58, see Figure 2.12. These photos show flames penetrating through the Black Side wall of the cafeteria due to a pressure rise in the early stage of the fire, see Section 3.1.2 and Appendix D. On the right photo of Figure 2.12, flames are seen on both sides of the cafeteria Black Side outer door.

Figure 2.12 FBI ground photos from the Black Side at 12:08:10 to 12:08:58. Flames penetrating through the Black Side wall of cafeteria are circled.

The large amounts liquid fuel ignited inside the cafeteria caused the flames evident in the FBI ground photos of Figure 2.12. The intense burning that followed the ignition of accelerants and other easily ignitable combustibles raised the pressure inside the cafeteria and pressed fuel vapor out through the thin and poor wall construction, see Annex D. No flames occurred around the door presumably because it was blocked to prevent the FBI from coming in.

Fire B in the cafeteria/kitchen area was not as sensitive to the wind in the early stage of the fire as there was no large opening on the leeward side of the building in the very beginning of the fire. The wind, however, did cause an under-pressure on the leeward side, i.e. the outside of Black Side wall of the cafeteria. The under-pressure in combination with the inside overpressure due to rapid fire development, see Section 2.4.2, caused the fire gases and flames to penetrate through the Black Side wall, see Figure 2.12.

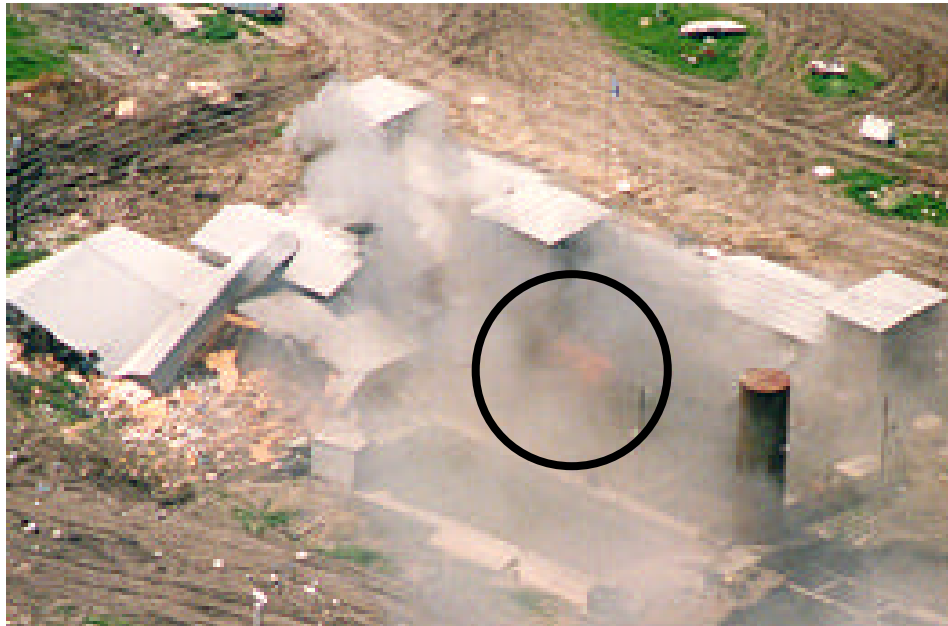
Photo 7-4

The first aerial photo showing flames of the cafeteria fire was taken at about 12:10:40, see Figure 2.13.

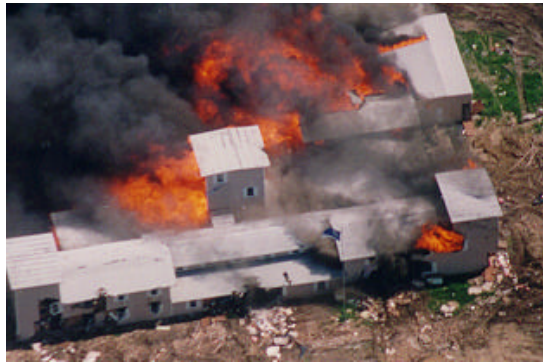
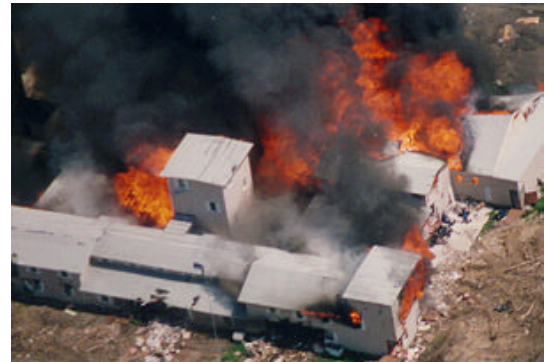
At about 12:14 p.m the cafeteria roof burns through, see the two consecutive photos of Figure 2.15.

Figure 2.15 Aerial photos at about 12:14 p.m. The cafeteria roof burns intensively on the left photo. On the right photo the roof has burnt through and the roof rafters are visible.

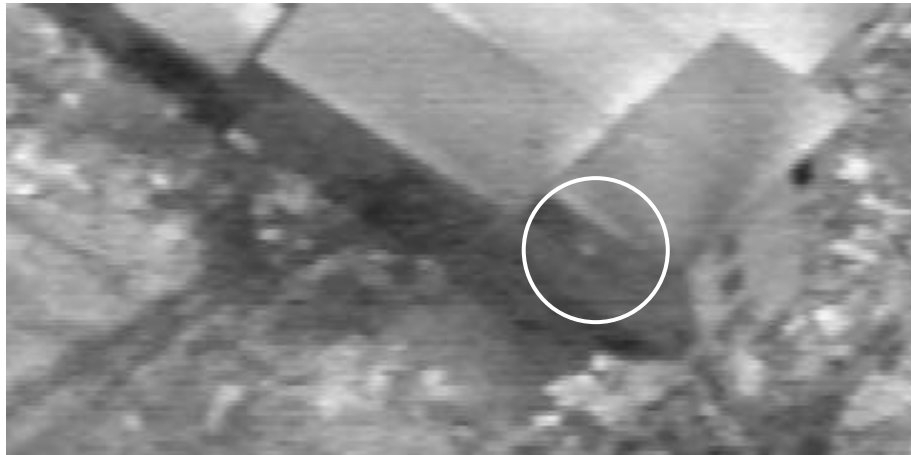
Figure 2.16 FLIR image 12:07:41. The first image of hot air is coming from the Red/White tower (circled).

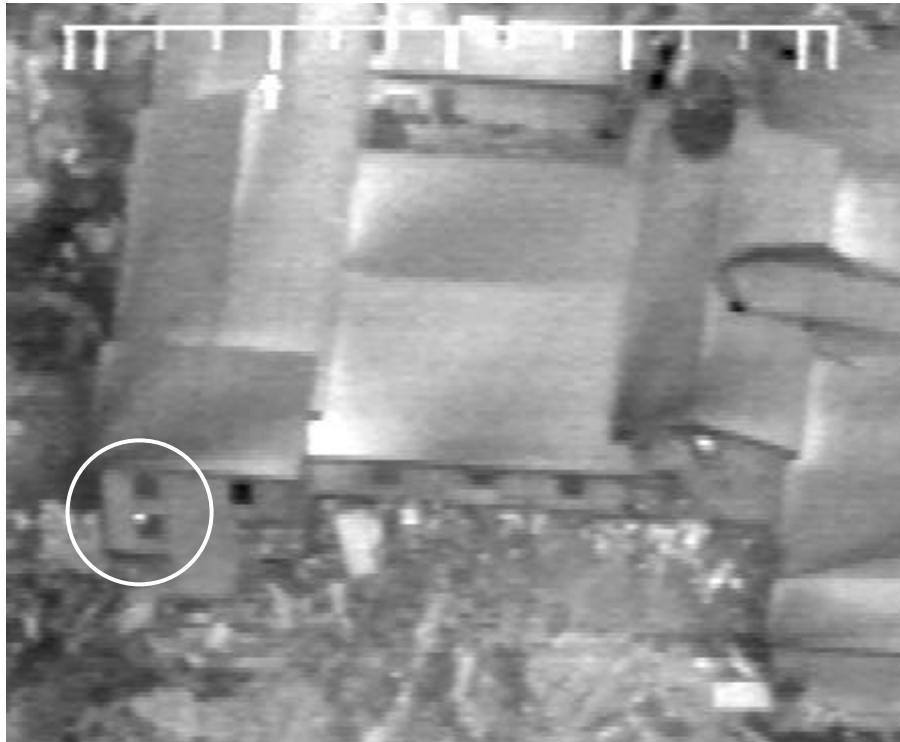
Figure 2.17 FLIR image 12:07:51. The first heat image in the second floor Red Side window of the Red/White tower (circled).

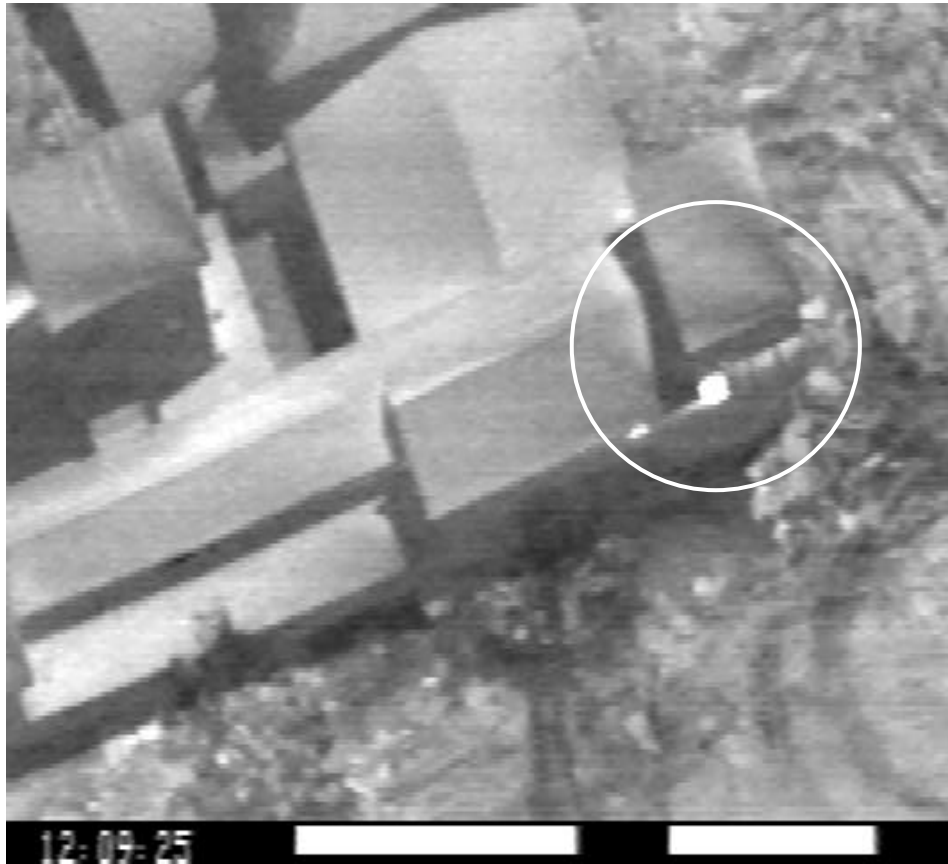
Heat images caused by conduction through the outer wall appear on the FLIR imagery at 12:09:09. Shortly thereafter at 12:09:25, see Figure 2.18, heat images are discovered in the second floor window to the left of the tower.

Figure 2.18 FLIR image 12:09:25. A bright heat image in the second floor window immediately to the left of the tower. Heat images also due to heat conducted through second floor tower wall. The wood studs appear as cooler (darker) than the fields between.

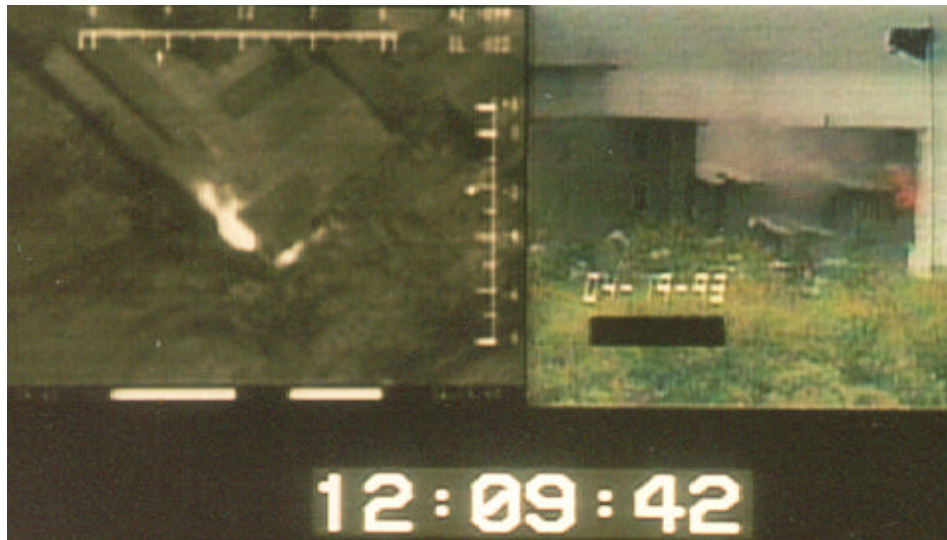
Figure 2.19 Simultaneous FLIR and TV-footage at 12:09:42. First flames emerging from the Red/White tower.

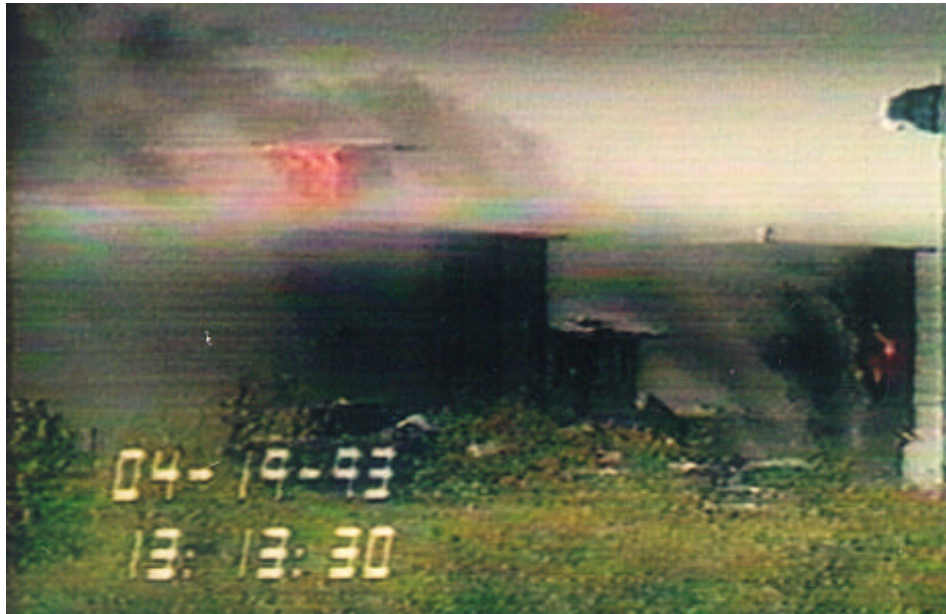
Figure 2.21 TV-footage at 12:13:49. Smoke belches out at the White Side of the between 12:13:49 and 12:16:50. (For correction of time, see Section 2.3).

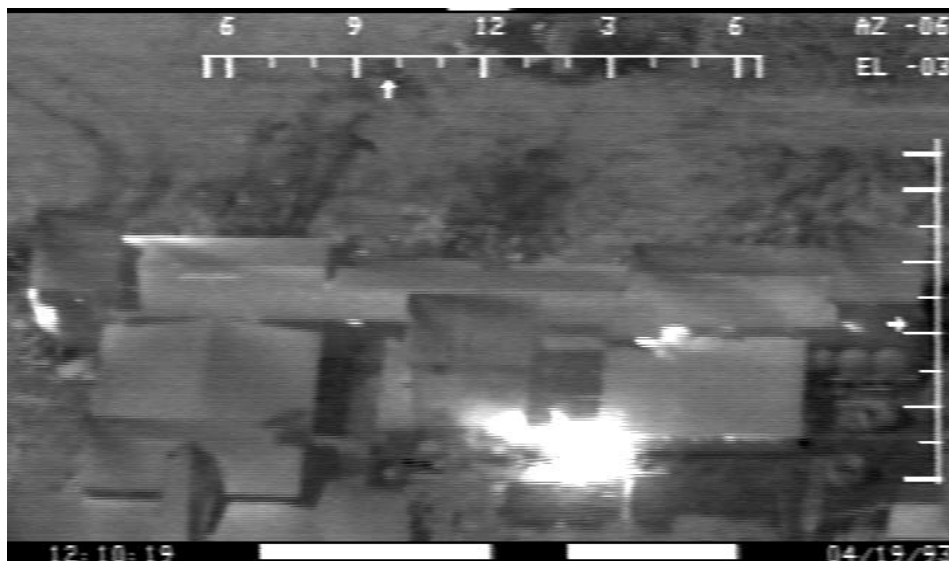
Figure 3.1 FLIR image 12:10:19. Hot gases are indicated in several places of the second floor and along the Black Side of the cafeteria.

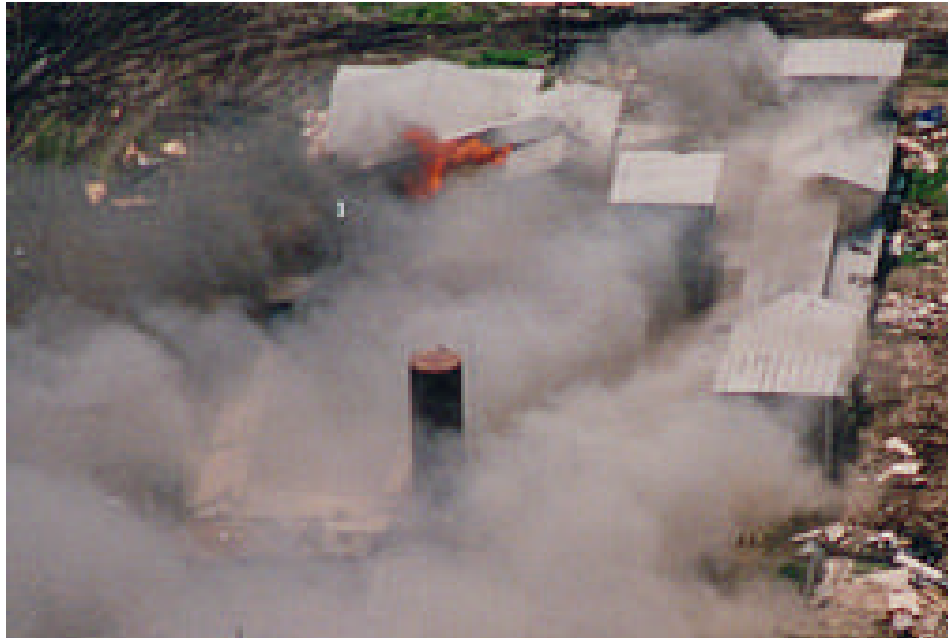
Photo 7-7

The fire at that early phase developed in the debris of the damaged gymnasium. At about 12:10 p.m. the roof covering on the catwalk ignited and burnt vigorously producing a large amount of black smoke, see Figure 3.2 and Figure 3.3.

Figure 3.2 Aerial photo at about 12:10 p.m. The fire in the debris of the damaged gym developed quickly and ignited the roof covering which burnt and produced large amounts of black smoke.

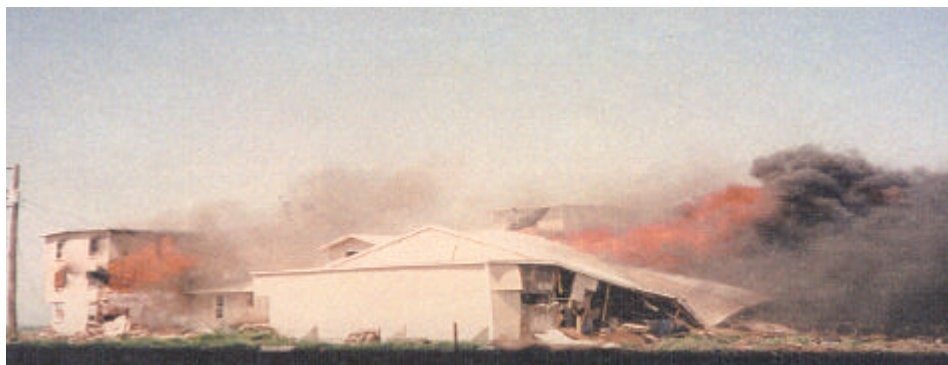
Figure 3.3 FBI ground photo from the Red/Black corner. The fire in the Red/White tower and the fire at the stage at the rear of the chapel are two separate fires.

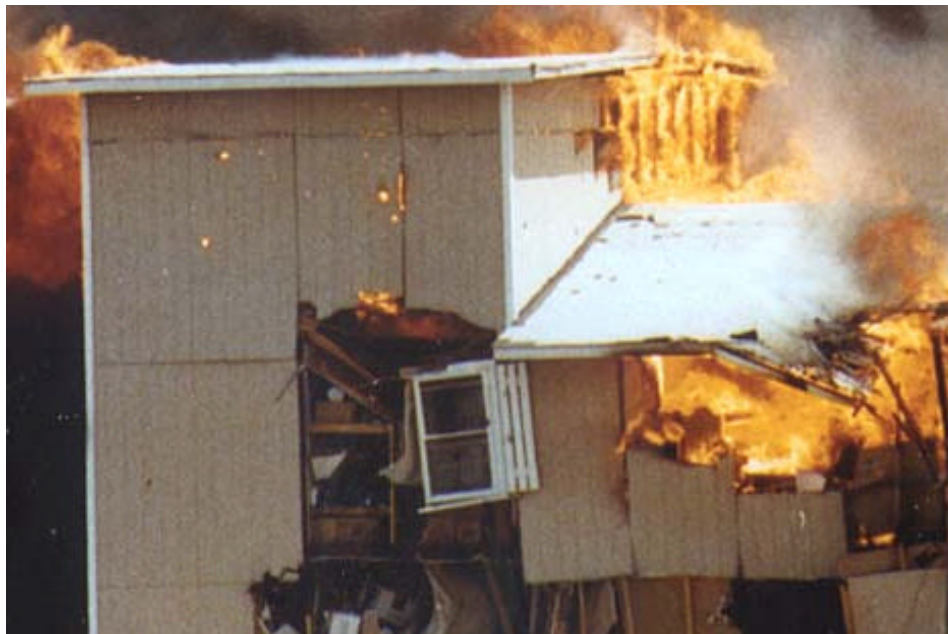
The cafeteria was more or less a closed space. As a result an overpressure was generated in the cafeteria when the temperature of the internal gas mass rose due to the fire. The windows were boarded and only two doors existed internally. To be clear there was no explosion. However, the pressure rose by approximately the same magnitude as the wind pressure or more, which was enough to force fuel vapor through the poor wall construction. At the time the photos of Figure 2.12 were taken, the Black Side wall of the cafeteria had already been exposed to fire for some time and had become damaged and more permeable. Figure 3.4 shows the White Side

Figure 3.4 FBI ground photo. The Green/White tower on fire. Similar holes as shown here on the third floor allowed flames to emerge out of the cafeteria Black Side wall in the very early stage of the fire, cf. Figure 2.12.

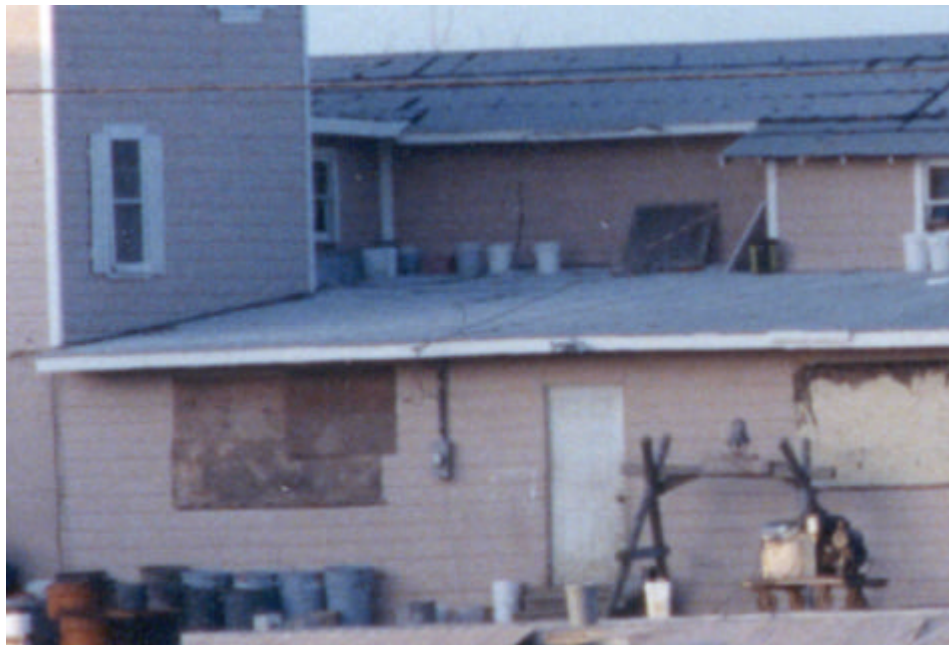
After the expansion of the gas mass inside the cafeteria (lasting 30 seconds or less), the fire intensity inside the cafeteria went down as the liquid accelerants were consumed and the oxygen concentration was reduced. The fire, however, continued to burn inside the cafeteria and at the eave of the roof. It appears that the board covering the window to the left of the cafeteria door fell down or was opened by the gas pressure allowing the hot fire gases to come out. This had a profound effect on the fire conditions in the cafeteria. Note in Figure 3.5 that the boarding of the window to the left of the door is weaker than the boarding of the window to right of the door. The patch in at the upper right corner of that boarding is not fastened in its lower left corner.

Figure 3.5 FBI ground photo from the Black Side of the cafeteria. The board covering of the window to the left of the door appears weak and may have fallen when liquid fuel was ignited and the interior pressure increased.

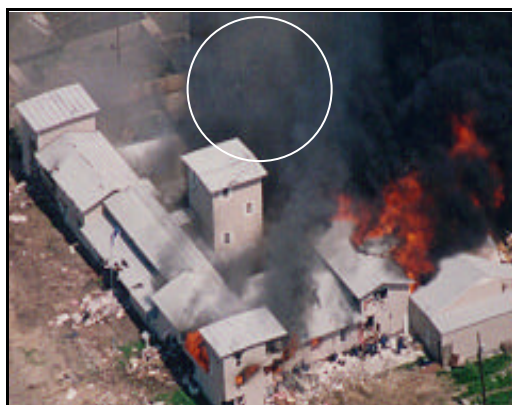
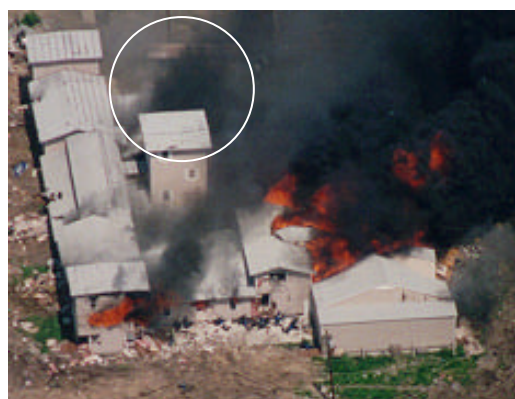
At around 12:12 p.m. the fire spreads to the roof and the smoke turns black from the cafeteria roof area, see behind the center tower in Figure 3.6. See also Figure 2.14. The black smoke comes from the burning asphalt of the roof covering.

Figure 3.6 Aerial photos at around 12:12 p.m. The smoke from the cafeteria area turns black when the roof covering starts to burn.

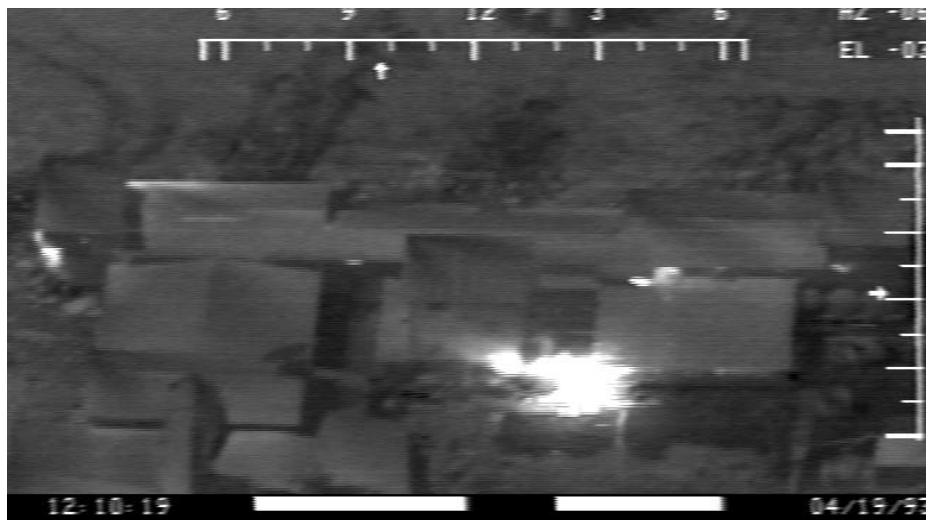
Figure 4.1 FLIR image 12:10:19. Hot gases or flames are indicated in the windows of the staircase and of the adjacent room.

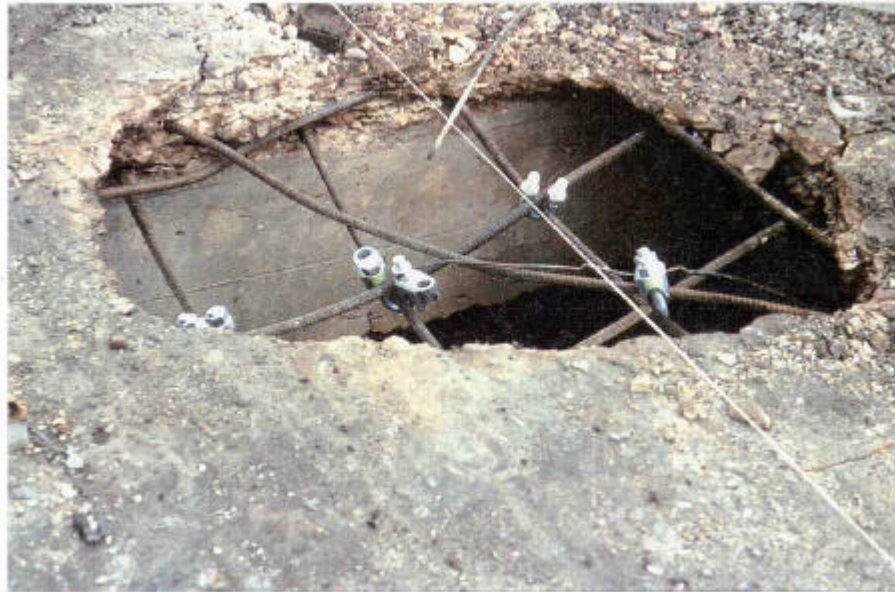
Finally I conclude, that the hole in concrete bunker roof was created by the heat from the fire. It was not made by a demolition charge as claimed by some experts.

Figure 6.1 FBI photo. The hole in the concrete ceiling slab of the bunker. Note the poor concrete quality.

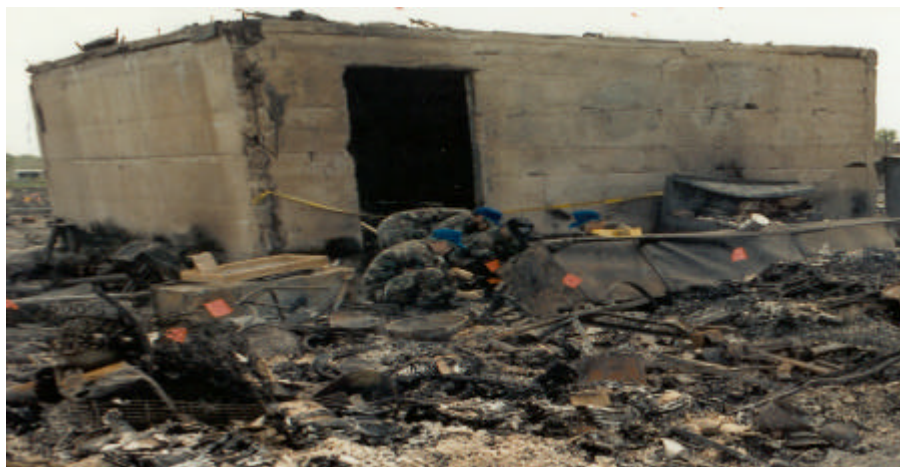
Figure 6.2 FBI photo. Bunker walls were made of plastered cinder blocks.

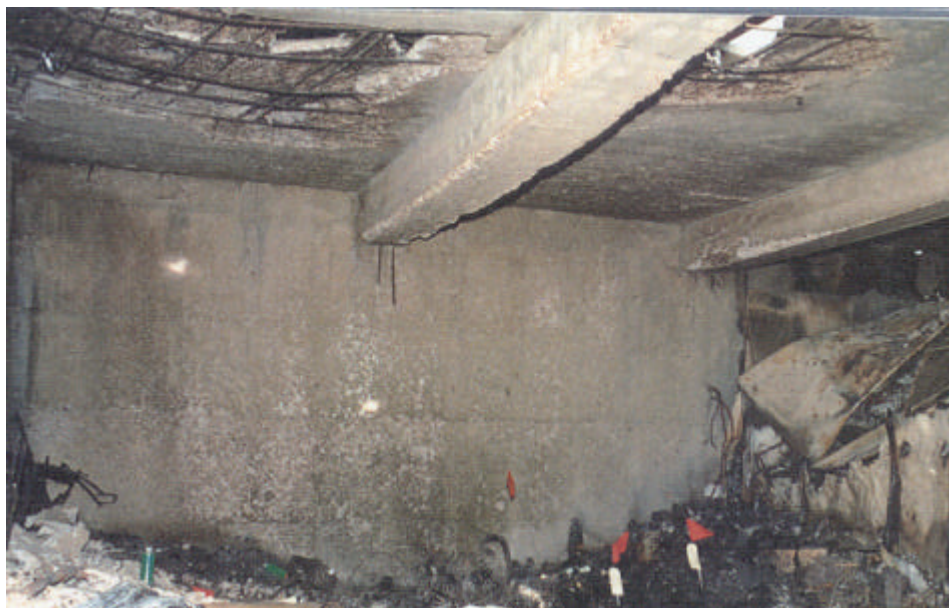
Figure 6.3 Spalling occurred at several places of the bunker slab due to intense fire exposure from below and from above.
