REPORT

Fire analysis of the events at Waco, Texas, 19 April 1993

The Office of Special Counsel

Ulf Wickström
SP, Swedish National Testing and Research Institute
Borås, Sweden
September 2000

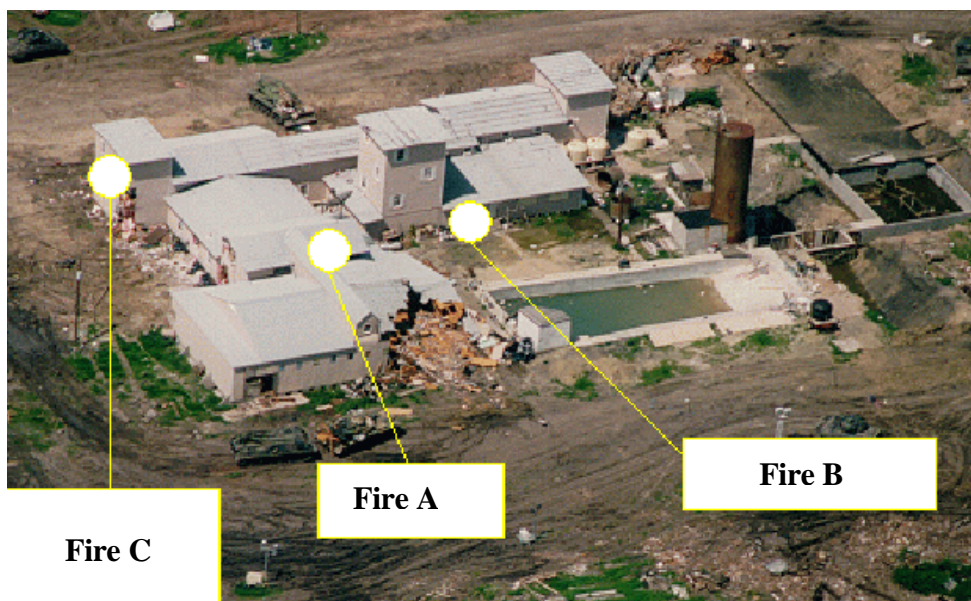
Fires were initially started in at least three locations. Events of these three fires are reported in separate sections below. Figure 2.3 taken from the Final Report of Walter Wetherington³ shows the positions of these fires. I agree with Mr. Wetherington's conclusions concerning the points of origin of the Branch Davidian fire and use his diagram here for illustration purposes.

Figure 2.3 The fire started at three separate locations denoted Fire A, B and C, respectively.

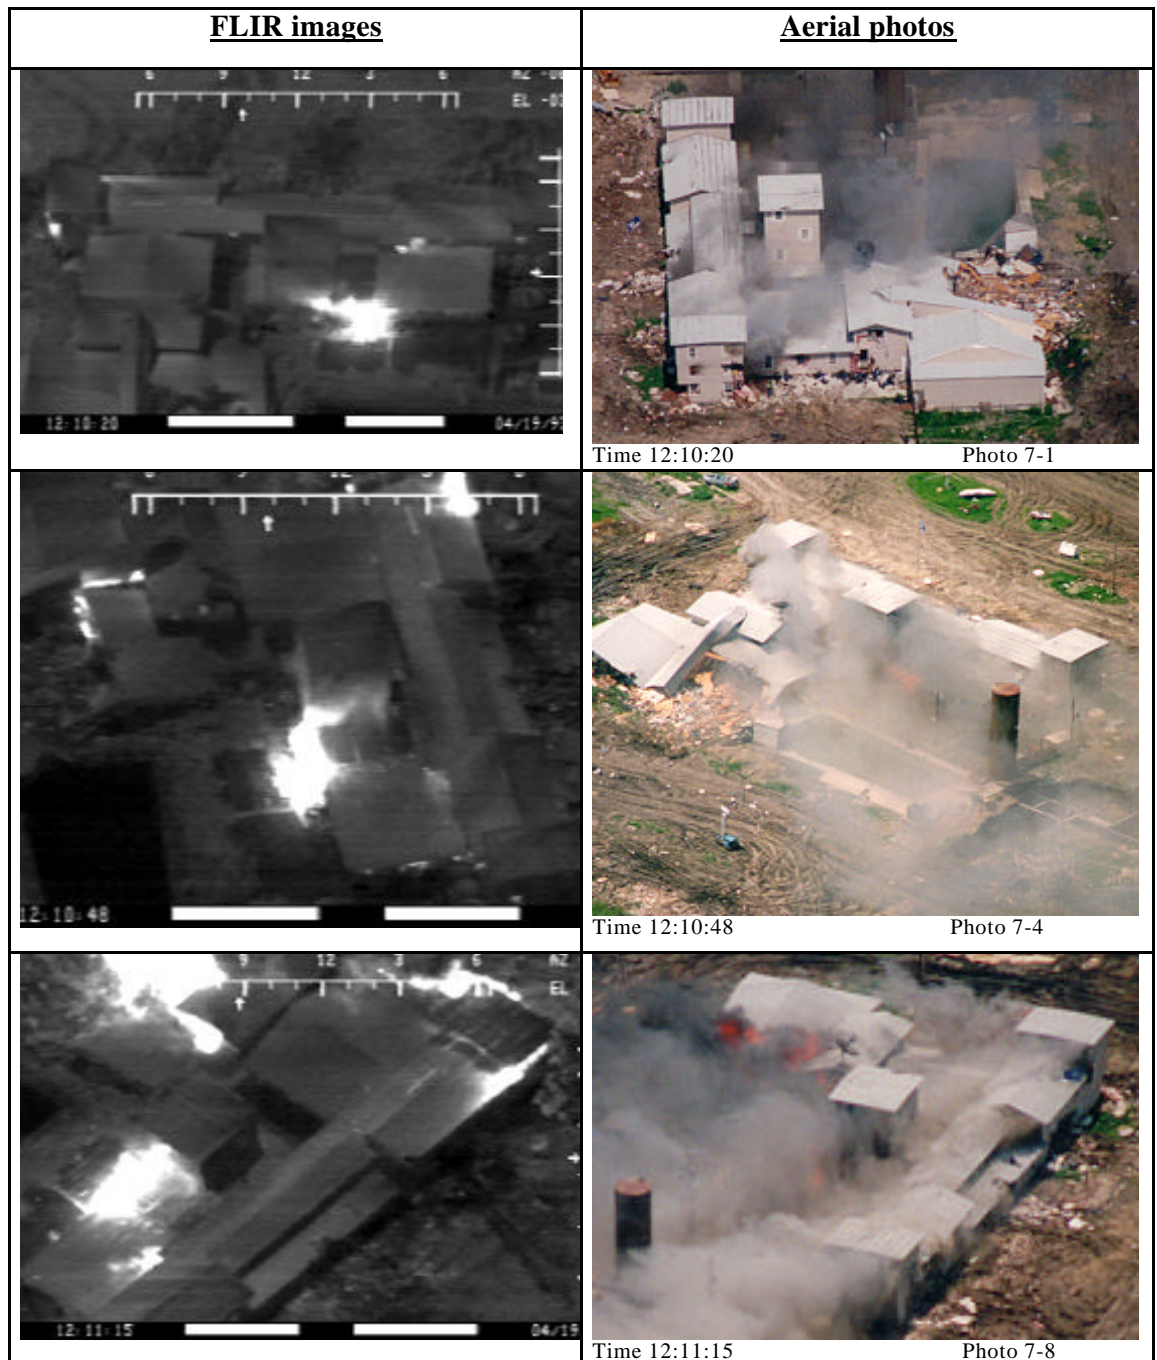
Figure 2.4 FLIR images and aerial photos taken at approximately the same times.

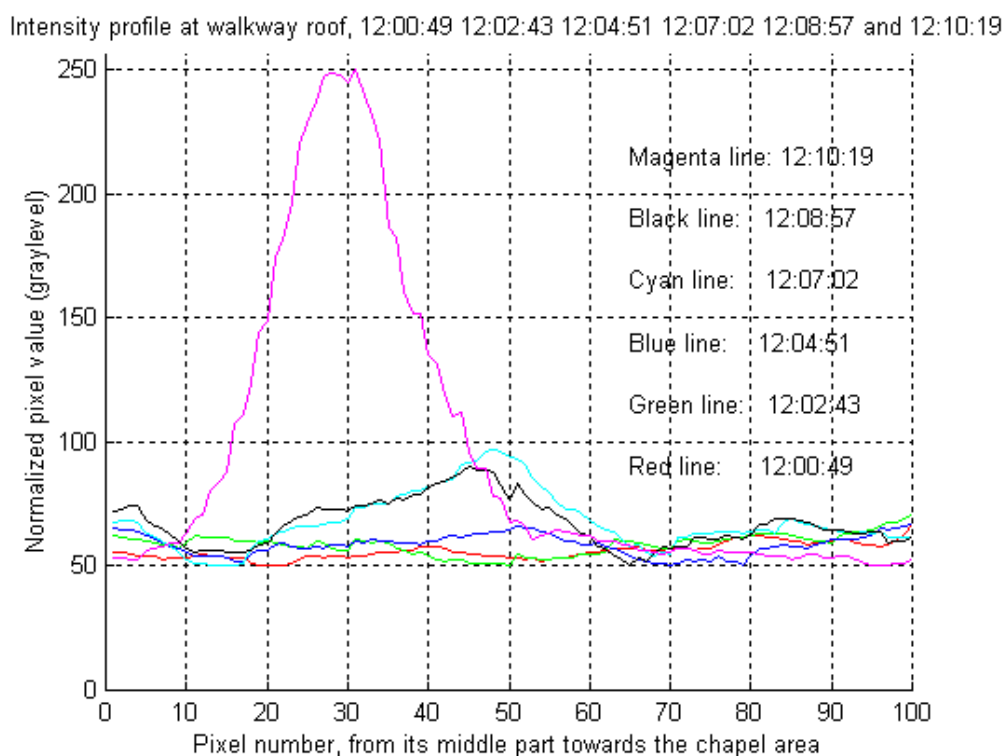
Fire A started under the catwalk near the stage at the rear of the chapel. The OSC experts Klasén and Madsen⁴ detected a faint heat image on the original FLIR tape at 12:04:23 at the eave of the collapsed catwalk roof. An indication of a temperature rise at the same location was derived by a detailed numerical analysis of pixels of the FLIR imagery by Klasén and Madsen⁴. This temperature rise on the catwalk roof occurs at 12:04:51. The third (blue) curve in Figure 2.5 plotted at 12:04:51 shows a slight temperature rise at a position where the temperature rise later on at 12:07:02 (cyan line) becomes evident, while the curve plotted before at 12:02:43 (green line) shows no heat increase.

Figure 2.5 Temperature along the eave of the damage catwalk above the gym and stage, cf. Figure 2.7 plotted at various times. The temperatures are obtained by numerical analysis of the FLIR tape. The blue curve shows the first indication of an onset of a temperature rise.

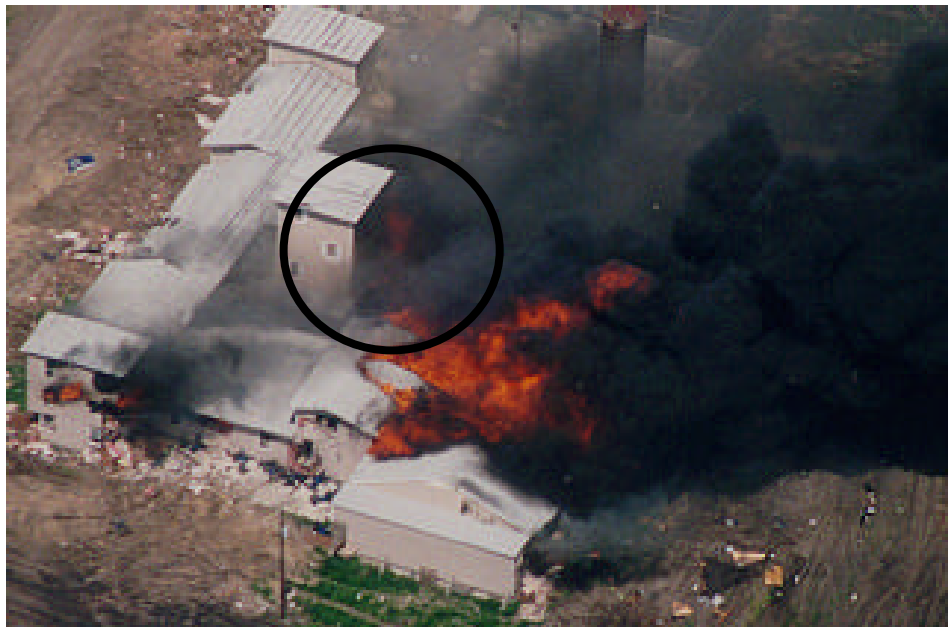
Photo 7-18

The flaming on the Black Side of the cafeteria increases and shortly before 12:12:25 black smoke starts to develop as the cafeteria roof ignites at the Black Side eave near the center tower, see Figure 2.14.

Figure 2.14 Aerial photo 12:12:25. The cafeteria roof has ignited and the smoke turns black.

At around 12:12 p.m. the fire spreads to the roof and the smoke turns black from the cafeteria roof area, see behind the center tower in Figure 3.6. See also Figure 2.14. The black smoke comes from the burning asphalt of the roof covering.

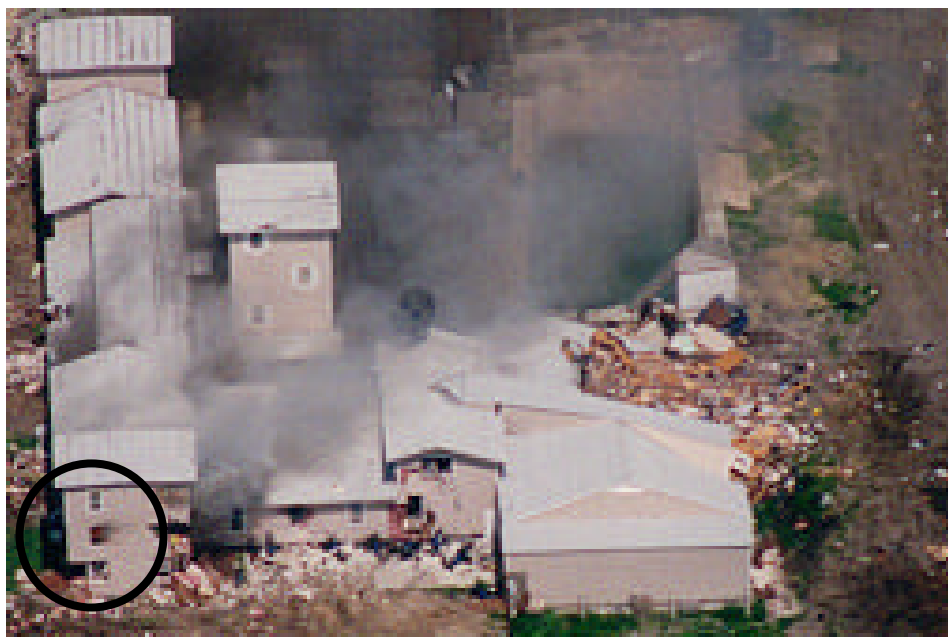
Photo 7-1

The first aerial photo showing flames in the Red/White tower was taken around 12:10:20, see Figure 2.20. The time estimate is based on the position of the CEV seen in lower left corner of the picture.

Figure 2.20 Aerial photo around 12:10:20. The first sighting of flames in the Red/White on aerial photos are seen in the second floor window.

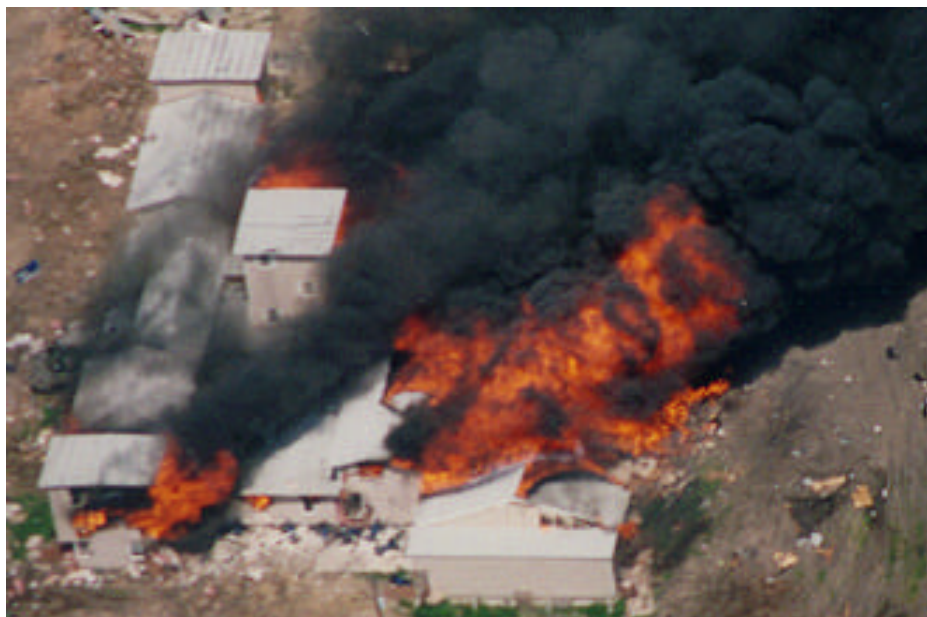
Photo 7-28

The wind cooled the fire in the early stage and therefore it took a rather long time for high temperatures to develop and full involvement or flashover to occur. In general after flashover, the fire becomes very hot and so much combustible gas is produced inside the compartment in relation to the ventilation, that these gases cannot burn inside the compartment, see also Section 1.6.2. Thus, as the time to flashover was extended due to the wind, the fire development was delayed and the fire did not spread into the second floor corridor in the center of the building until a relatively late stage. Ultimately, the fire spread with the wind moving towards the chapel and igniting its roof at about 12:14 p.m. Note in Figure 3.7 how the smoke at the Red/White tower has turned black, as the asphalt of the chapel roof covering has started to burn.

Figure 3.7 Aerial photo at 12:14:10. The fire in the Red/White tower spreads with the wind and ignites the chapel roof.

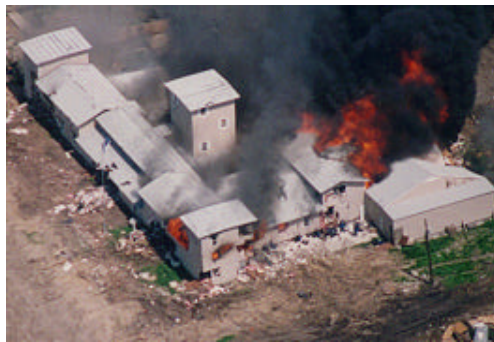
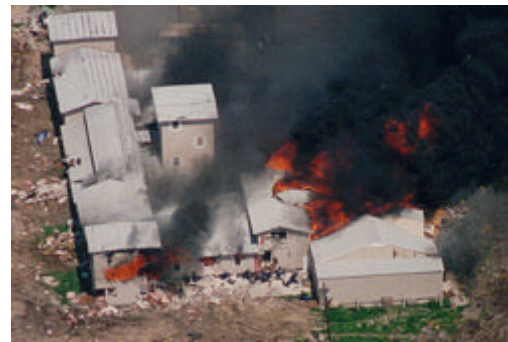
Fire C in the Red/White tower was started using large amounts of liquid fuels. Flames emerged at 12:09:42 from the second floor White Side window of the tower. At this early stage of the fire the wind forced the flames of the mainly liquid fire out the tower windows. Flames then continued to emerge out the windows alternatively from the White Side and the Red Side, see Figure 3.8. Without the wind, the flames would have stayed at one position heating and igniting the ceiling and the walls within a couple of minutes.

Figure 3.8 Aerial photos at 12:12:30. Two consecutive photos. The flames appear alternatively from the white and the Red Side tower windows. Intensive flames in the chapel.

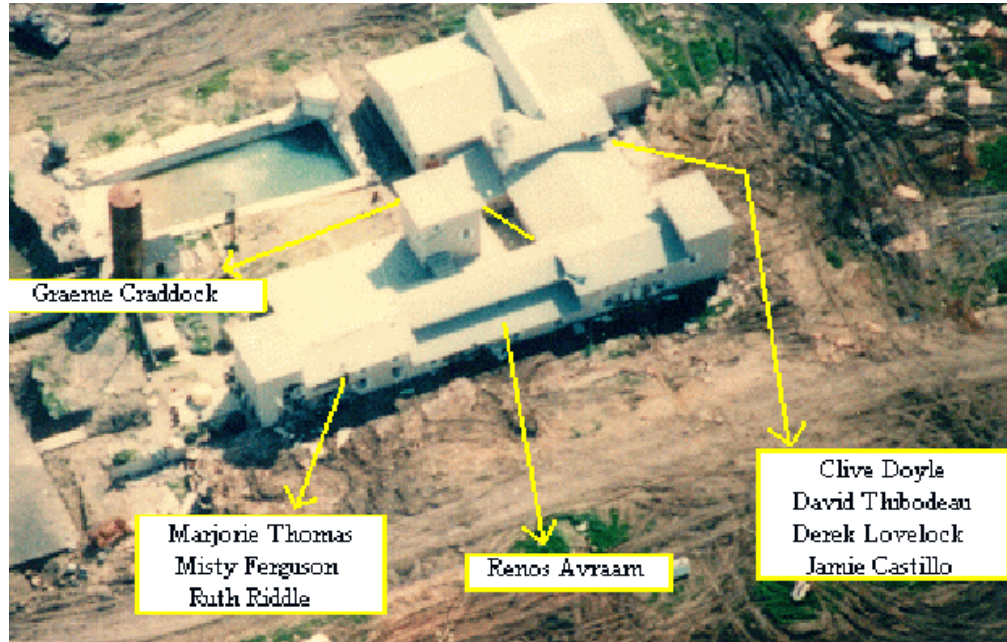
staircase. Figure 4.2 from the final report of Walter Wetherington³ shows generally where nine Davidians escaped the fire.

Figure 4.2 Davidians' escape routes from fire. This drawing is reproduced from the final report of Walter Wetherington³.

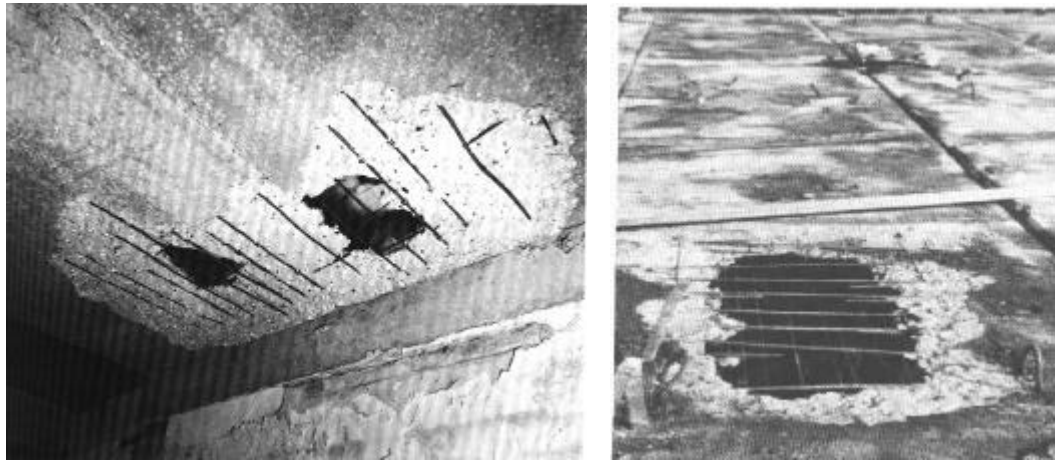
3. Spalling is generally a random phenomenon, but is quite common. Figure 6.4 shows two examples from the literature of spalling of fire exposed concrete structures.

Figure 6.4 Example of spalling of concrete structures exposed to fire found in the literature⁵.

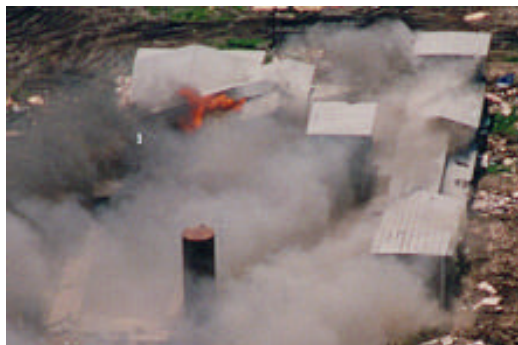
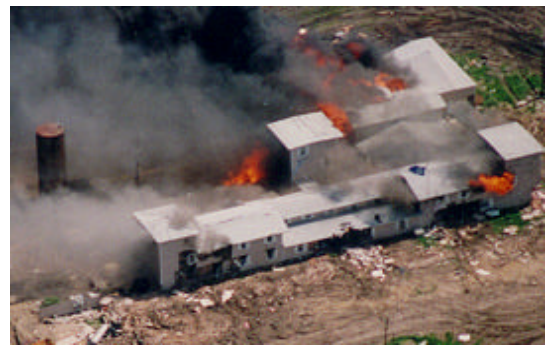
Based on the FLIR video and photos like the one in Figure 7.1, I am strongly convinced that fires started in at least three separate locations. Mr. Kennedy expressed doubt in using the FLIR recordings as evidence for the fire development. Even without the FLIR imagery it is clear that the fire started in at least three locations.

Figure 7.1 Aerial photos approximately 12:10:30 and 12:11:45, respectively.

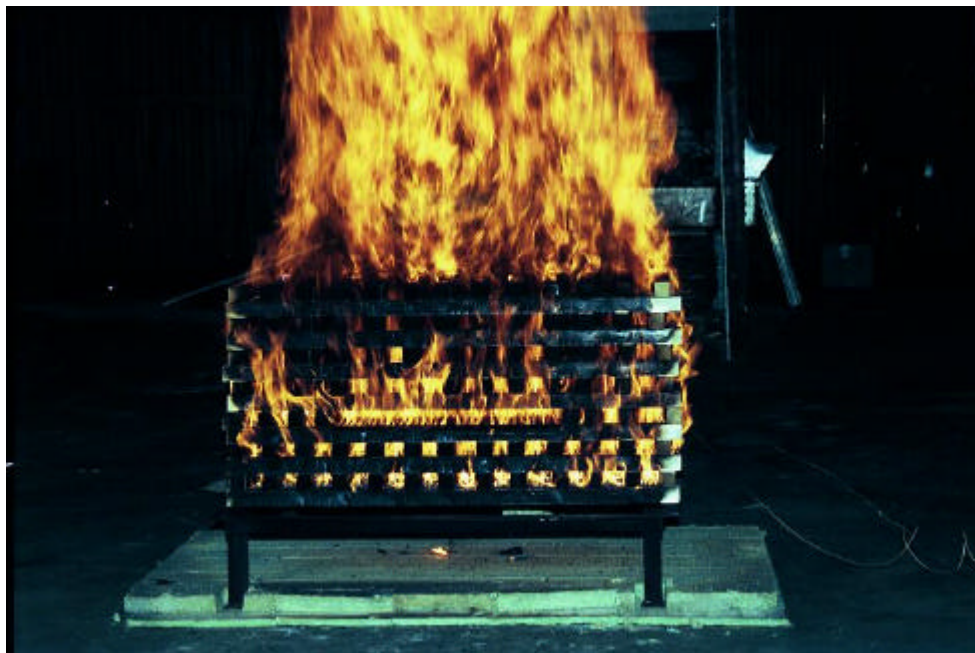
The wood crib had access to air from all sides including from below and burnt intensively at high temperatures for about one hour.

Figure 3 The crib burnt intensively at high temperatures. The specimens were placed inside the crib.

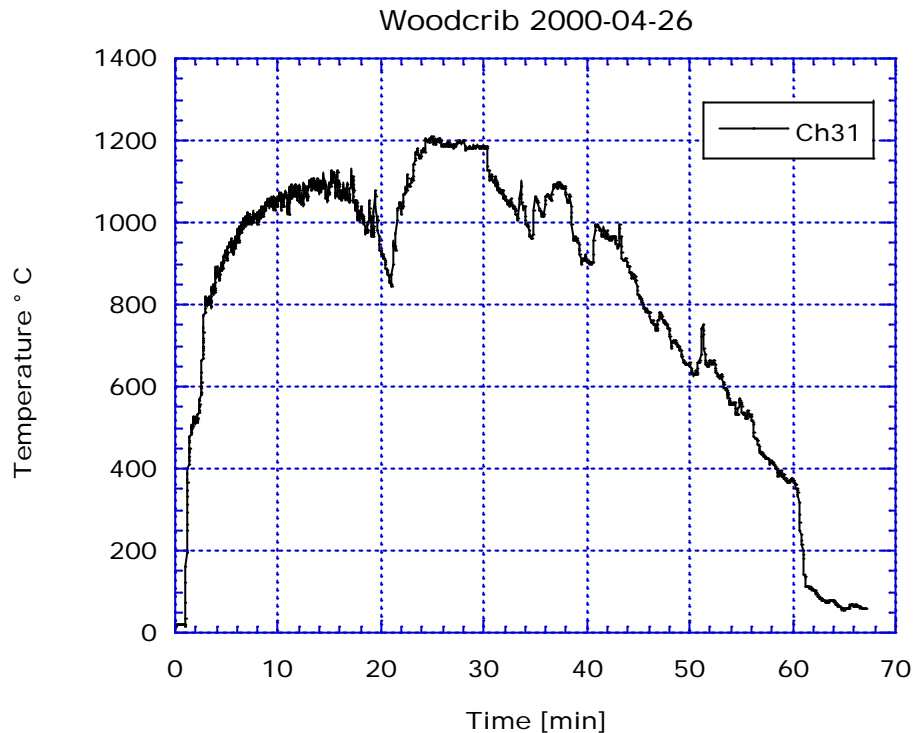
Temperatures above 1000 °C were recorded for a period of 35 minutes, see figure 4.

Figure 4 Temperature recorded in the wood crib near the specimen.

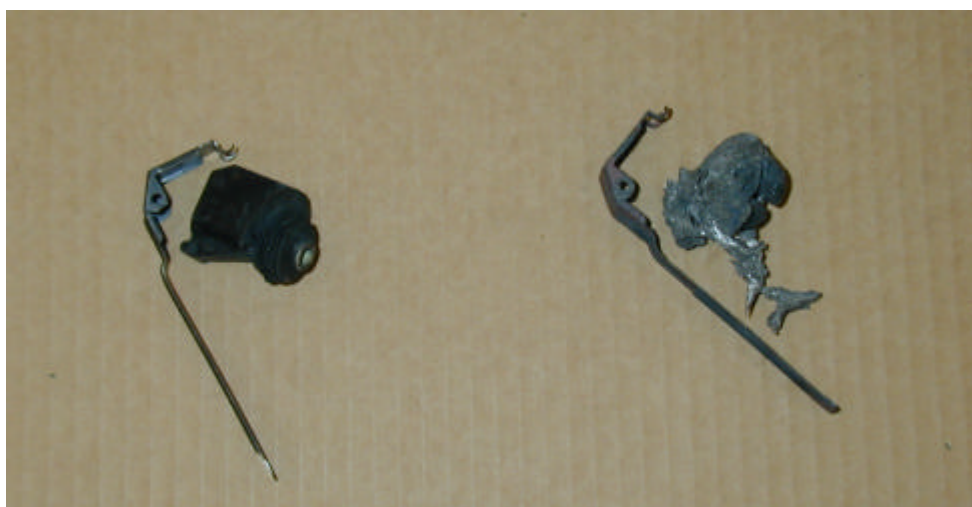
Figure 5 Item 1, Evidence Label No. A00811749 - Lever and cap from expended hand delivered flash bang grenade, not tested and tested, respectively.

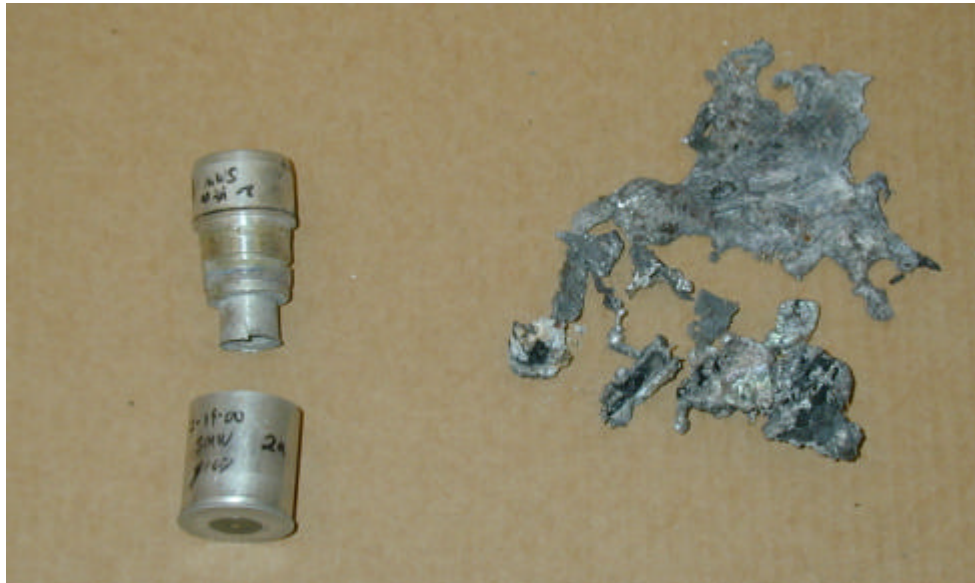
Figure 6 *Item 2 Evidence Label No. A00811748 - Forty millimeter flash Bang casing and projectile fired from a M-79 Grenade Launcher, not tested and tested, respectively.*

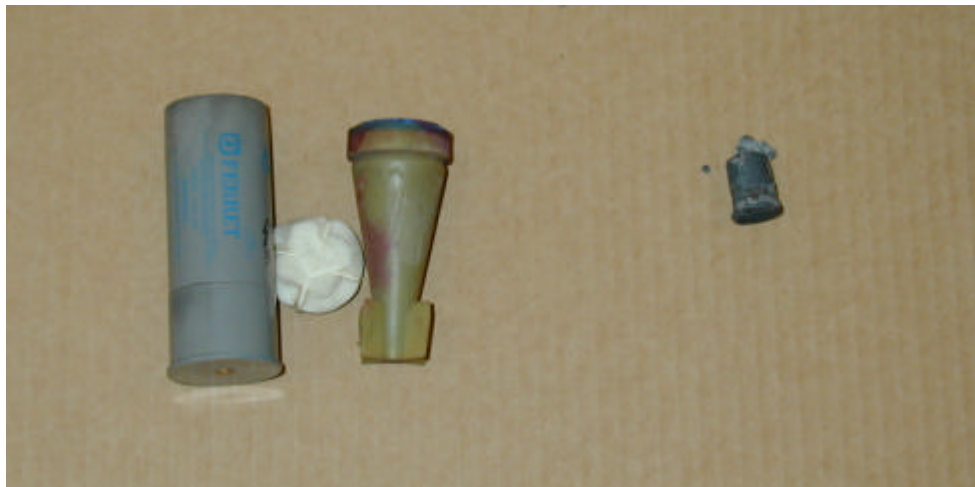
Figure 7 *Item 3 Evidence Label No. A00811108 - Forty millimeter Ferret casing, wadding and projectile, not tested and tested, respectively. The remainder is a piece from the casing.*

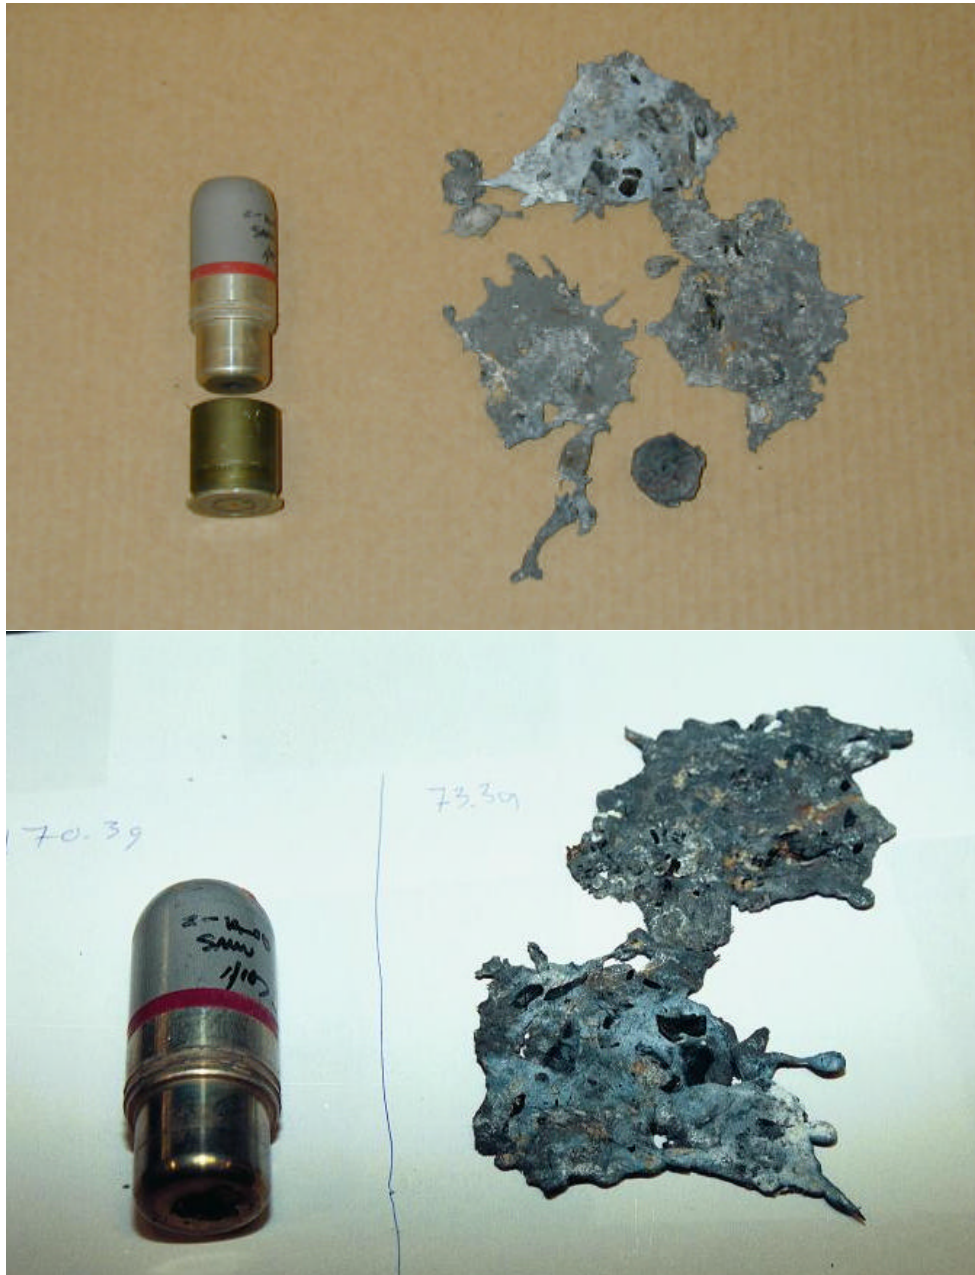
Figure 8 Item 4 Evidence Label No. A00811102 - Forty millimeter XM651E1 casing (military rounds) and spent projectile, not tested and tested, respectively. The lower picture shows the projectile only.

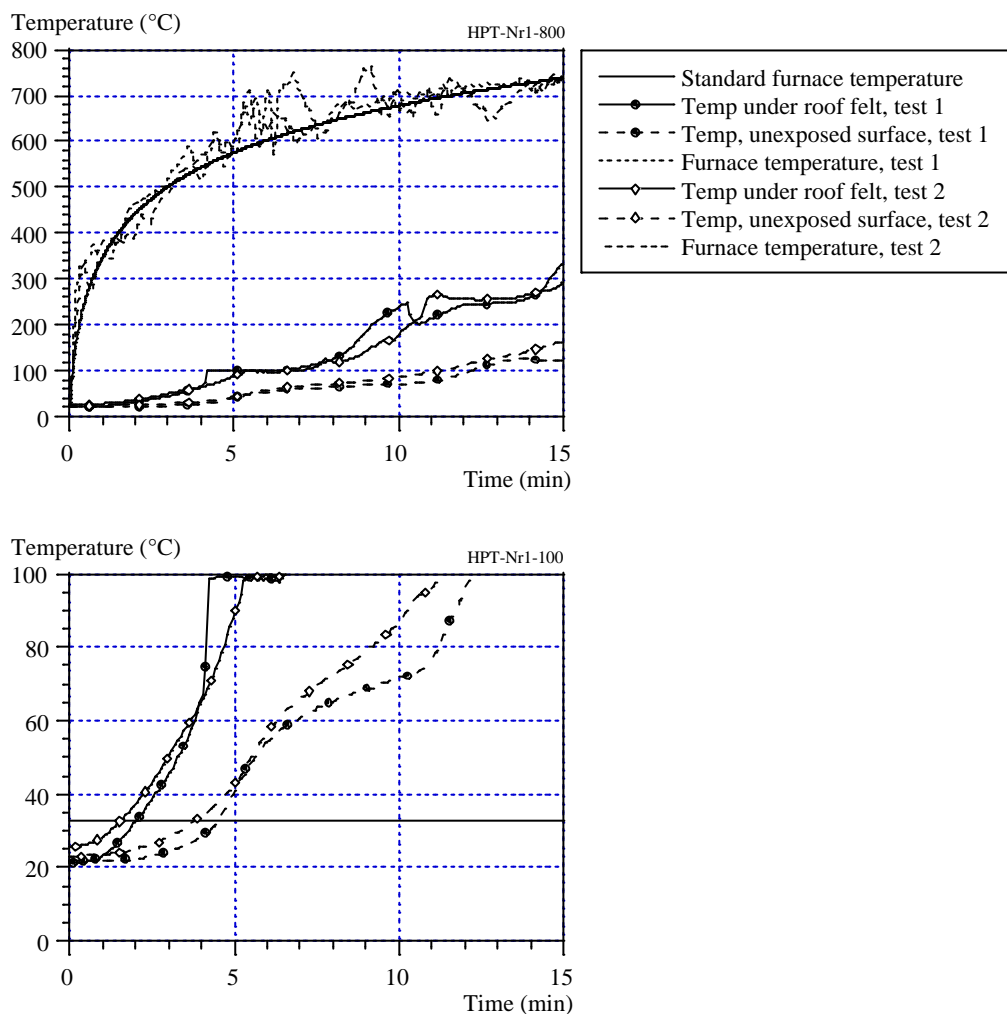
Figure 2 Temperature development of roof construction when exposed to standard furnace temperature according to ISO 834. Two temperature scales. A temperature rise of 10°C above the average of the initial temperatures of all four thermocouples is indicated in the higher resolution diagram at the very bottom.

The diagrams in Figure 2 show the recorded temperature of the duplicate tests as a function of time in the furnace: at the interface between the plywood and the roof covering (under the roof felt), and at the top of the covering (unexposed surface). For clarity the 10°C temperature rise is in the bottom diagram, which has magnified temperature scale.

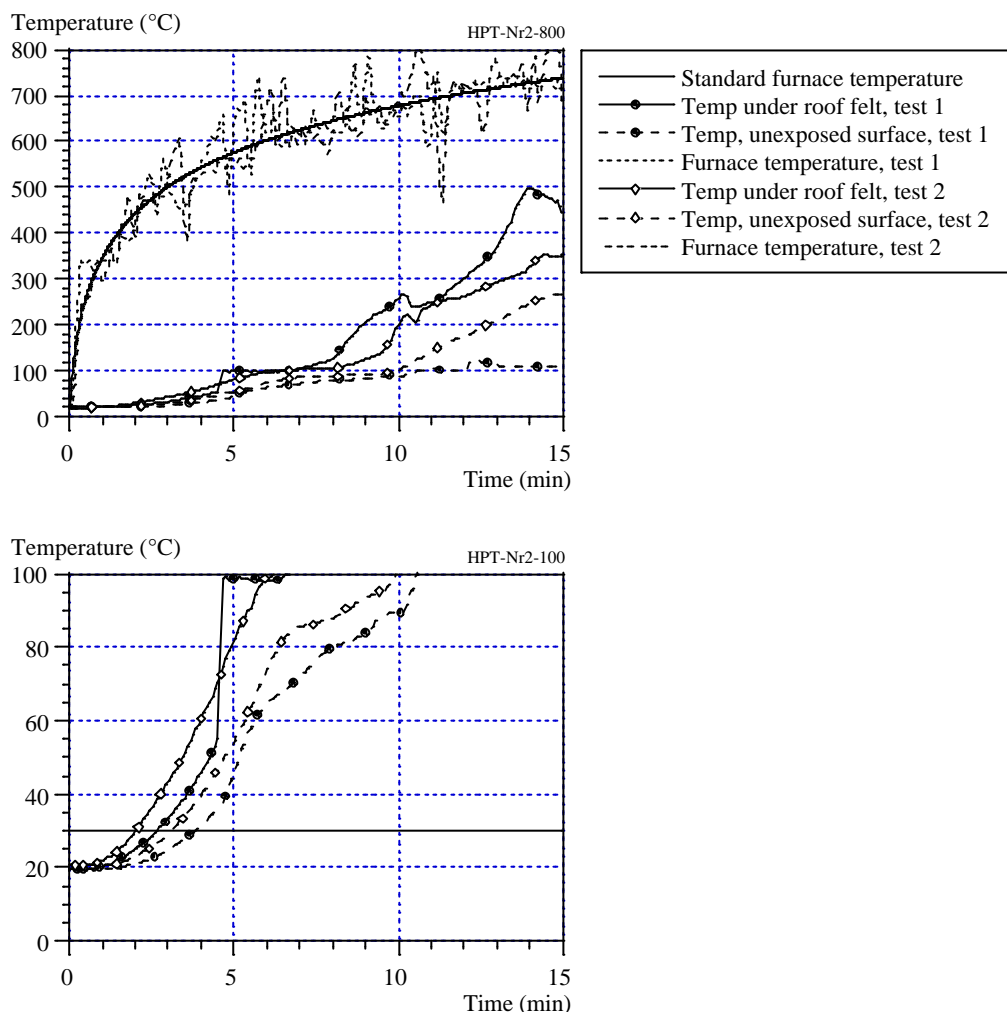
Figure 2 Temperature development of roof construction when exposed to standard furnace temperature according to ISO 834. Two temperature scales. A temperature rise of 10°C above the average of the initial temperatures of all four thermocouples is indicated in the higher resolution diagram at the very bottom.

The diagrams in Figure 2 show the recorded temperature of the duplicate tests as a function of time in the furnace: at the interface between the plywood and the roof covering (under the roof felt), and at the top of the covering (unexposed surface). For clarity the 10°C temperature rise is in the bottom diagram, which has magnified temperature scale.

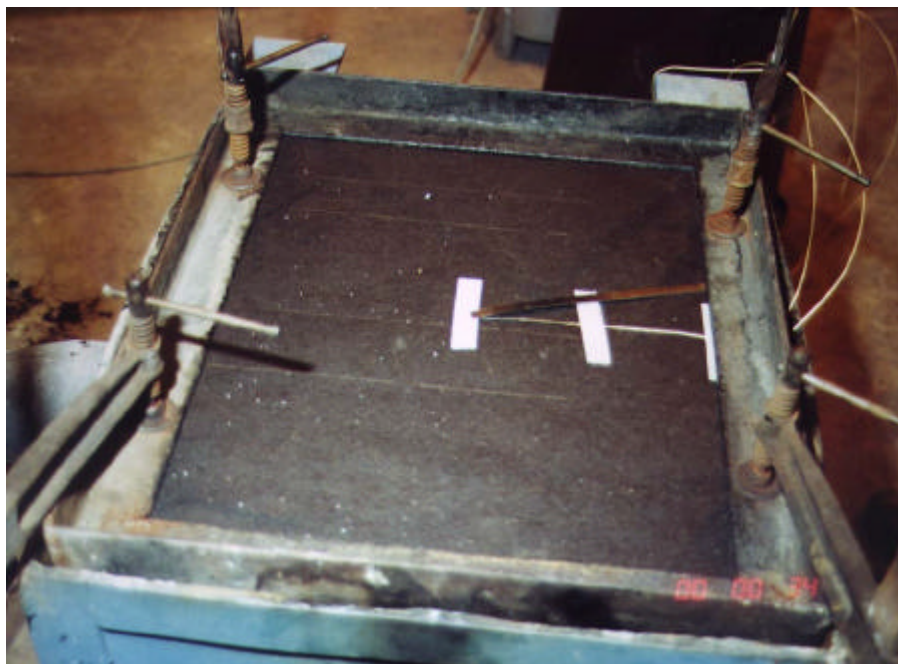
Figure 1 Specimen on top of the small fire resistance furnace, specimen size 500 mm by 600 mm.

Observations	Time, (min:s)	
	No. 1:1	No. 1:2
Start of test	0:00	0:00
A pressure increase under the roof covering forced the surface to bend.	10:00	13:00
The asphalt started to melt.	13:30	11:00
Small amounts of smoke started to appear.	17:30	-
Small amounts of smoke started to appear.	-	19:00
The smoke production was evident.	-	21:00
Fire broke through the surface and the smoke production was evident. The test was terminated.	21:00	-
Fire broke through the surface. The test was terminated.	-	23:00

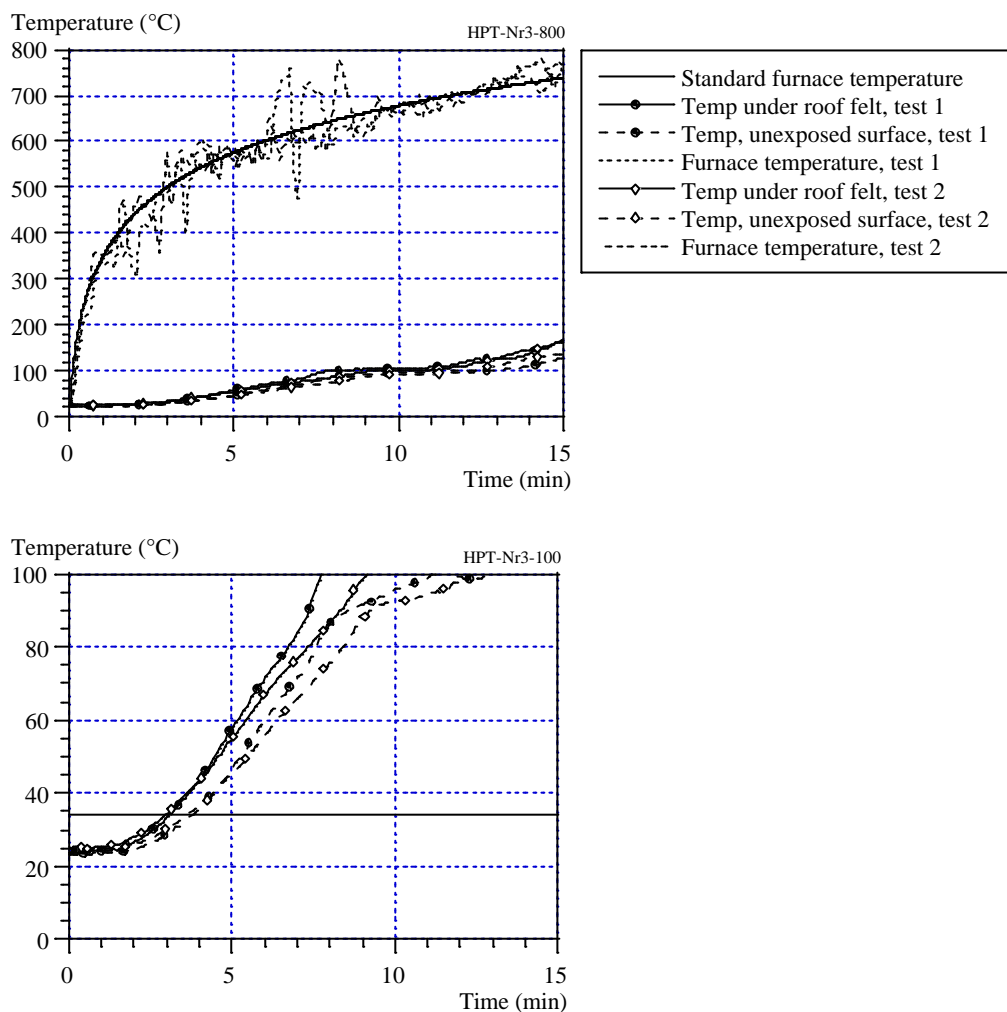
Figure 2 Temperature development of roof construction when exposed to standard furnace temperature according to ISO 834. Two temperature scales. A temperature rise of 10°C above the average of the initial temperatures of all four thermocouples is indicated in the higher resolution diagram at the very bottom.

The diagrams in Figure 2 show the recorded temperature of the duplicate tests as a function of time in the furnace: at the interface between the plywood and the roof covering (under the roof felt), and at the top of the covering (unexposed surface). For clarity the 10°C temperature rise is in the bottom diagram, which has magnified temperature scale.

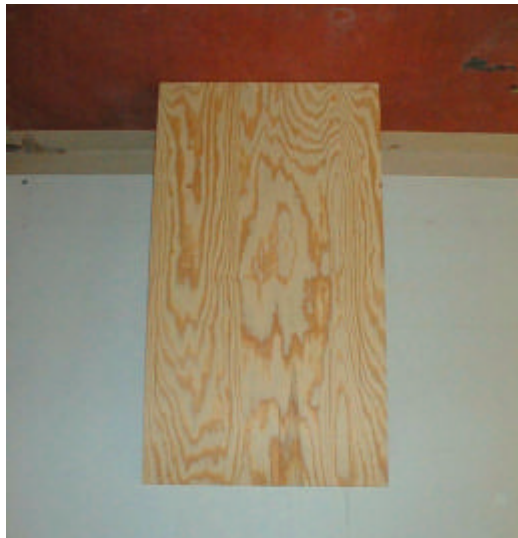
Figure 1 The received sample of plywood 3/8” without any surface treatment.

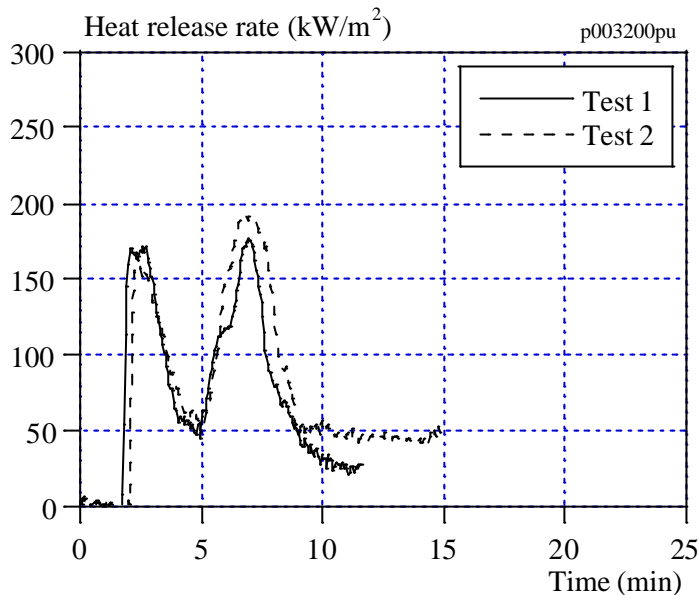
Figure 2 Heat release rate for plywood 3/8" without any surface treatment, double tests at an irradiance of 25 kW/m².

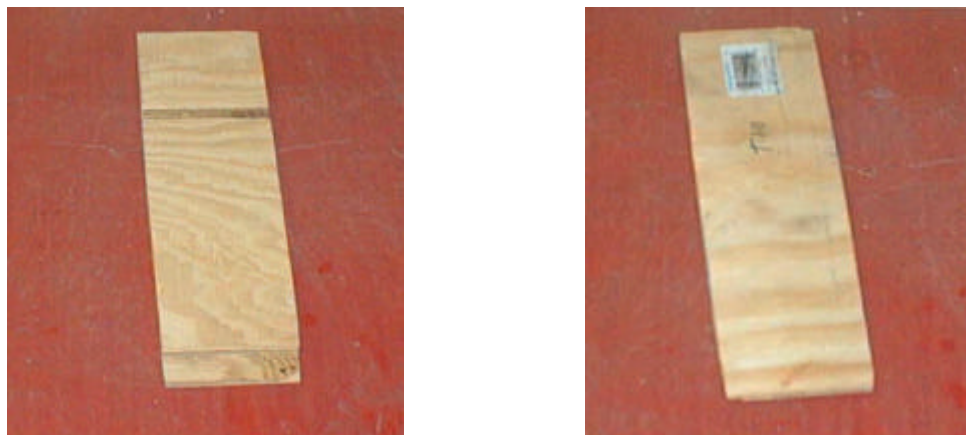
Figure 1 The received sample of plywood 5/8” with external side grooves. The left photo shows the external side. The un-grooved side was exposed to the radiant heat.

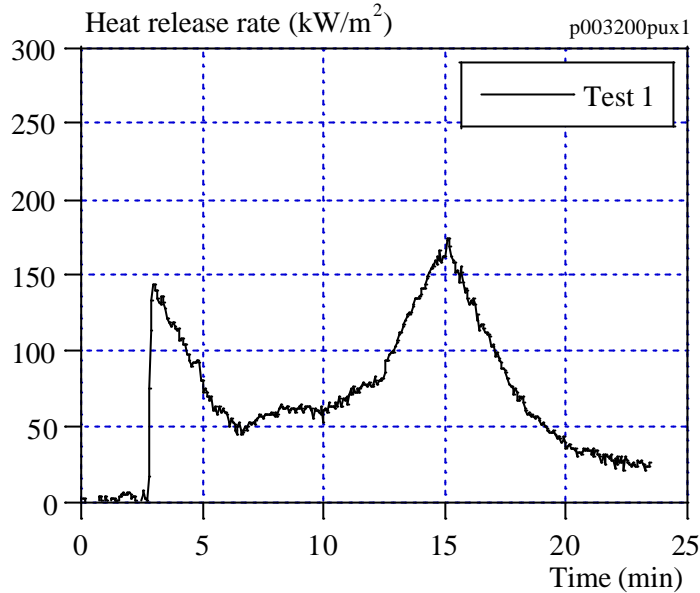
Figure 2 Heat release rate for plywood 5/8" with external side grooves, single test at an irradiance of 25 kW/m².

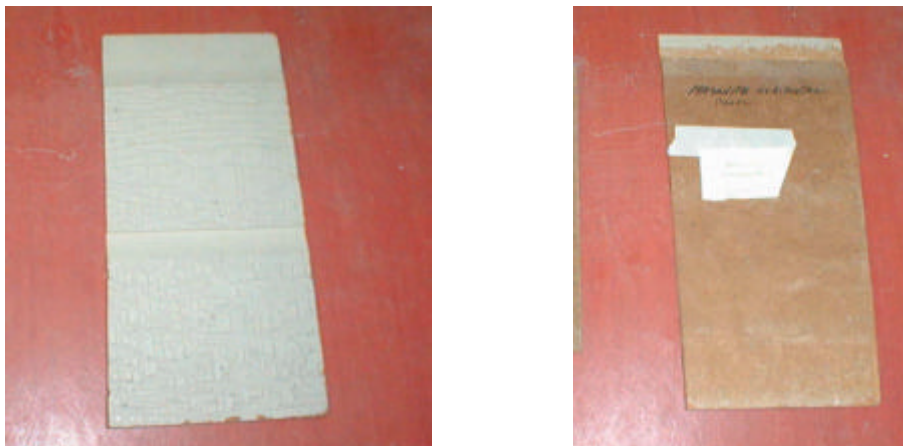
Figure 1 The sample of masonite 1/2” with external side treatment 1. The left photo shows the external side. The inside was exposed to the radiant heat.

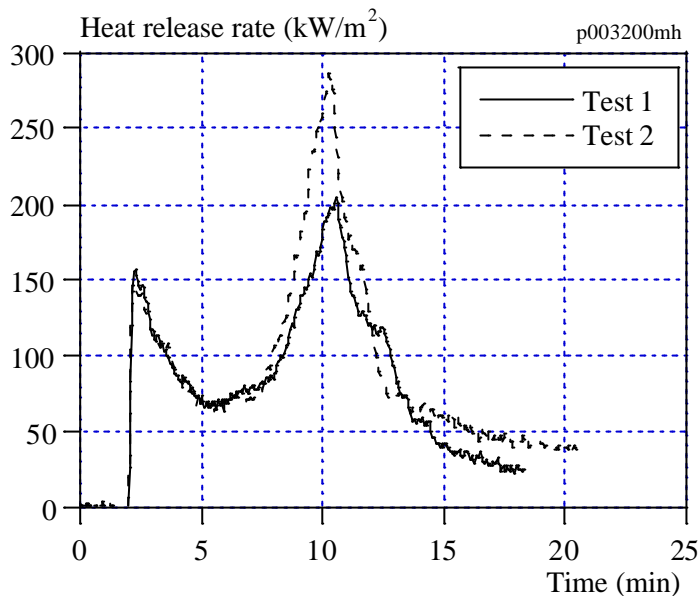
Figure 2 Heat release rate for masonite 1/2" with external side treatment 1, double tests at an irradiance of 25 kW/m².

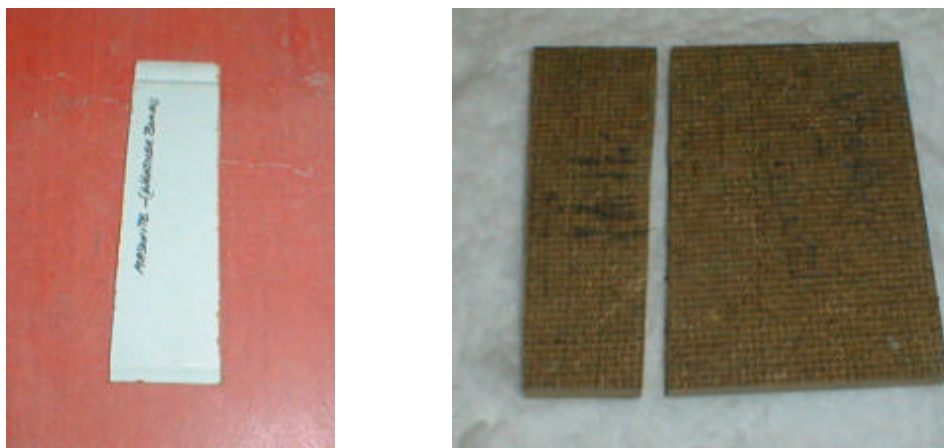
Figure 1 The received sample of masonite 3/8” with external side treatment 2. The left photo shows the external side. The photo to the right shows the side of the test specimen, which was exposed to radiant heat. The specimen had to be comprised of two pieces due to the insufficient width of the sample.

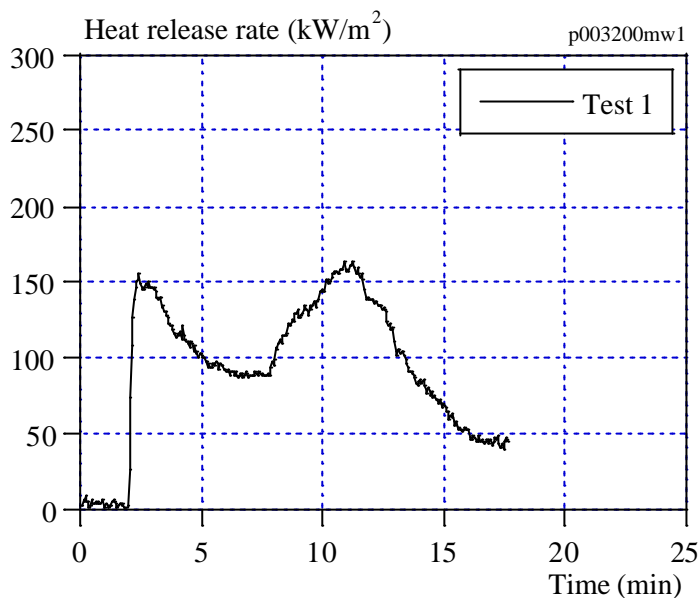
Figure 2 Heat release rate for masonite 3/8" with external side treatment 2, single test at an irradiance of 25 kW/m².

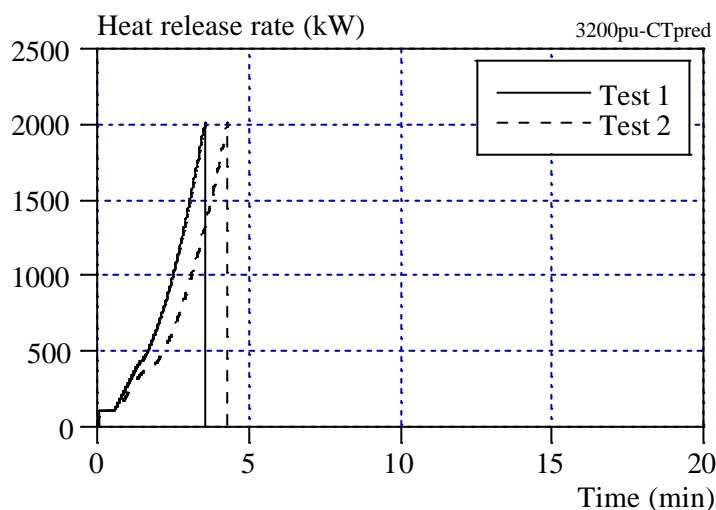
Property	Test 1	Test 2
Ignition time used (min:s)	1:44	2:02
Predicted flashover time (based on a heat release rate of 1000 kW) (min:s)	2:29	3:06

Figure 1 Predicted heat release rate in the Room/Corner Test (ISO 9705) based on Cone Calorimeter tests for plywood 3/8” without any surface treatment.

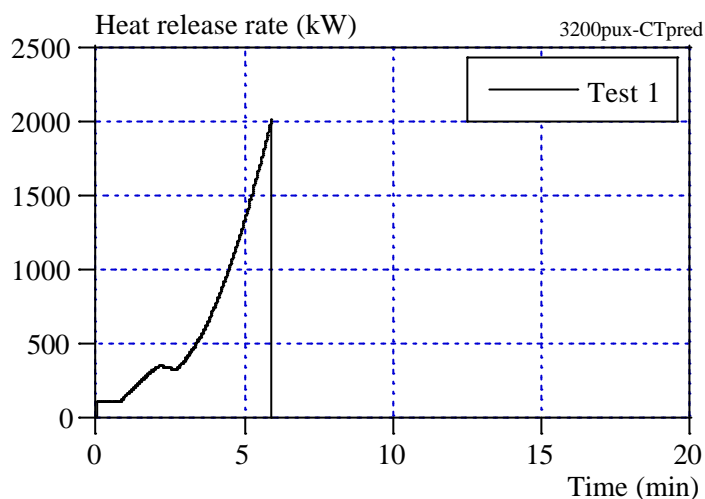
Property	Test 1
Ignition time used (min:s)	2:43
Predicted flashover time (based on a heat release rate of 1000 kW) (min:s)	4:29

Figure 2 Predicted heat release rate in the Room/Corner Test (ISO 9705) based on Cone Calorimeter tests for plywood 5/8" with external side grooves.

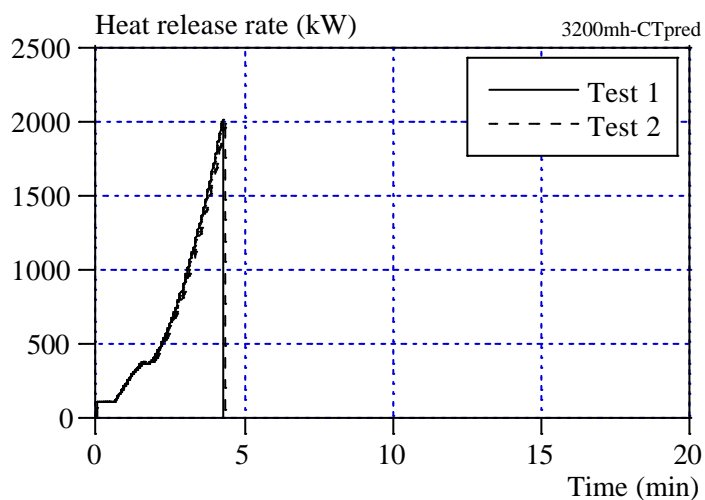
Property	Test 1	Test 2
Ignition time used (min:s)	1:57	1:59
Predicted flashover time (based on a heat release rate of 1000 kW) (min:s)	3:06	3:12

Figure 3 Predicted heat release rate in the Room/Corner Test (ISO 9705) based on Cone Calorimeter tests for masonite 1/2" with external side treatment 1.

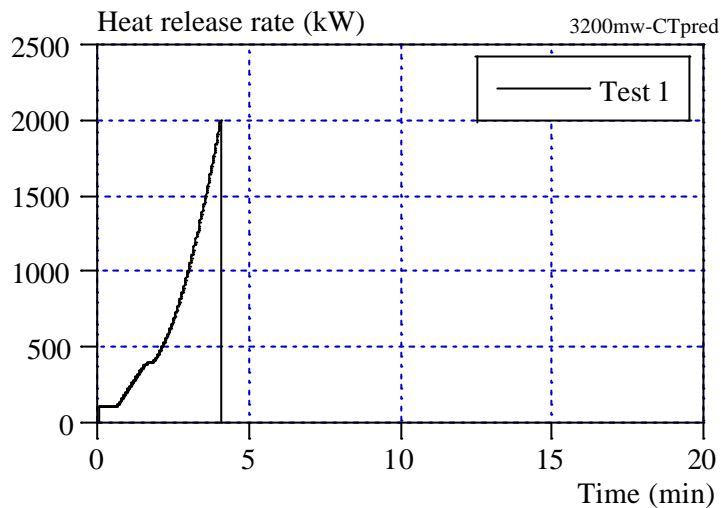
Property	Test 1
Ignition time used (min:s)	1:59
Predicted flashover time (based on a heat release rate of 1000 kW) (min:s)	3:00

Figure 4 Predicted heat release rate in the Room/Corner Test (ISO 9705) based on Cone Calorimeter tests for masonite 3/8” with external side treatment 2.
